## **Restoration proposal for correction of pathologies in concrete bridge - case study in the city of Teófilo Otoni, Brazil**

In the national scenario, countless bridges deteriorate with the need for structural restorations, which have been neglected for years. Not unlike this scenario, in the municipality of Teófilo Otoni, the same problem occurs, where there are numerous bridges in need of restoration and with different pathologies. Thus, this case study aims to analyze the pathological manifestations of the bridge located at João Lopes da Silva Street, Manoel Pimenta neighborhood, Teófilo Otoni - MG, indicating which repairs should be performed, treating each pathology individually. It is a small and spanned reinforced concrete bridge, with a mixed structure, located on an urban road.

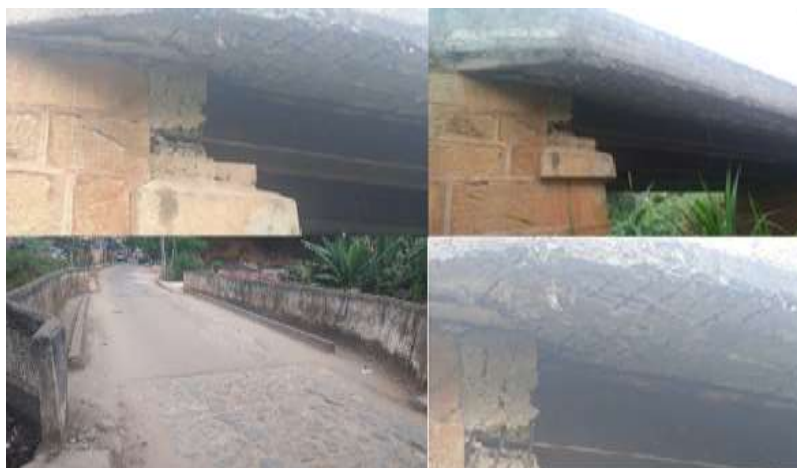
In Figure 3, the main pathologies diagnosed in the concrete structure under study are presented. The degradation and segregation of the concrete are visible, there is a concentration of coarse aggregates at the bottom of the slab and the support, and the reinforcement of the structure and the effects of its corrosion are observed. In addition, the surface elements of the structure show clear signs of moisture and infiltration, probably caused by some failure in the drainage elements. There are signs of the leaching process and the presence of salt deposits (efflorescences). Such pathological manifestations have probable origins thanks to the inadequate design, the execution of the work, or the quality of the materials used, possibly such problems are aggravated by the lack of periodic maintenance and age of the work, according to Helene (1992).

**Figure 3.** Pathological manifestations found in the analyzed bridge.

It is important to observe, in Figure 3, the pathologies described above, such as the loss of concrete cover, leaching process and accumulation of salts, believed to have originated since its execution, which occurred incorrectly.

The breakdown of the concrete can be verified in the structure tray and characterized by the deterioration of the concrete by fragmentation of its parts, caused, in the great majority, by the expansion as a result of the oxidation or expansion of the reinforcements, by the increase of the volume of concrete, when it absorbs water, and also due to insufficient openings in the expansion joints, causing unforeseen tangential tensions. It can also occur due to the action of structural movements and

shocks in the structure (Bastos & Miranda, 2017; Laner, 2001). The concentration of gravel in the lower faces may indicate a process of corrosion of the concrete by physical-chemical processes, an error in the execution phase, especially in the casting and curing part of the concrete, or in the design part (insufficient coverage).

The degradation and segregation process of the concrete in the structure under analysis can be caused by the poor quality of the material and the inadequate production, casting, or curing of the concrete. Failures and obstructions in the drainage devices can generate an accumulation of local water and/or increase in moisture in the concrete, intensifying the corrosive processes (Silva, 2017).

The corrosion of the reinforcement verified in the construction can be justified by a possible porosity of the concrete, small cracks in the material, or even a deficiency in the covering, exposing, partially or totally, sections of the steel. Therefore, such factors may have allowed the frames to be affected by aggressive elements over the years, thus causing their oxidation. In addition, the oxidized part can increase its volume by up to eight times and the force of the expansion expels the concrete from the covering, as can be seen in Figure 1, totally exposing the reinforcement to the aggressive action of the medium. The continuity of this phenomenon leads to the destruction of the framework (Vitório, 2003; Barbosa et al., 2012).

The degradation of the structure may be related to corrosion of the reinforcement since it is known that this process has a physical, chemical, or electrochemical origin; the last two being the most important and generically called corrosion. Thus, the first procedure in the recovery of this pathology is the removal of corrosion from the reinforcement. However, to have access to the entire damaged area of the reinforcement, it is necessary to assess the need to shore up the area to be recovered and carry out the scarification of the concrete in this location. In addition, as there was no decrease of about 10% in the section area, it will not be necessary to add more steel bars as a structural reinforcement. However, anti-corrosion protection (such as anti-corrosion paints in civil construction) must be applied to reinforcements that have been exposed and have undergone oxidation (Zamodzki et al., 2019).

The next step in the intervention about the concrete disintegration is the evaluation of the resistant section of the concrete that remained after cleaning and scarifying the disintegrated portion of the support. Such an evaluation will allow the adoption of different solutions for each case, which may or may not require shoring and range from the occasional addition of coating mortar, for the simplest cases, to the adoption of ways to redo the concreting of the section to be recovered. Due to the state of disintegration of the analyzed bridge, it is proposed to use forms for concreting and correcting the pathology in an efficient and architecturally harmonious way to the original structure, according to Villanueva (2015).

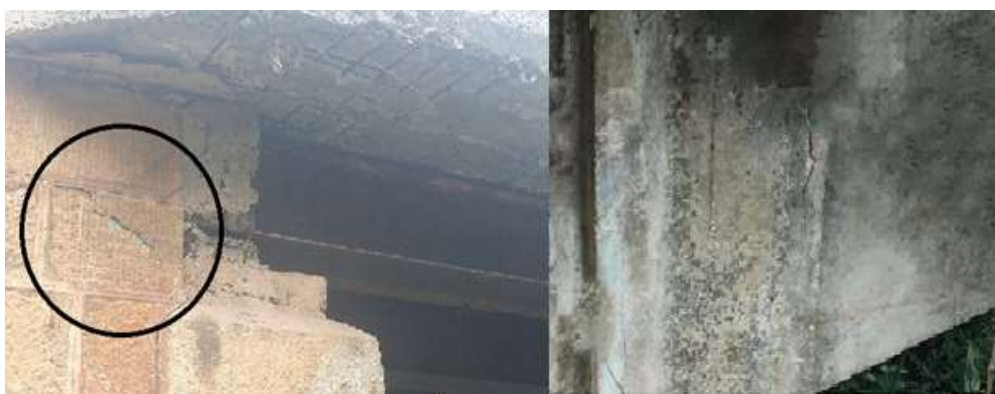
In Figure 4, it is possible to see the pathology of fissure and efflorescence. Cracking is characteristic of the event in which the resistive stress of the part of the structure receives more stresses than it can withstand. Cracks, even those of very small dimensions, facilitate the continuous deterioration of concrete by corrosion processes, which can compromise the structure. In addition, they may indicate the presence of stresses not foreseen in the artwork or even the loss of the structure's resistive capacity. Efflorescence, according to Neville (1997), is more likely to occur when cold and rainy weather is followed by a dry and hot period, which is recurrent in the city of Teófilo Otoni, given its climatic variations. It is also possible to identify, in Figure 4, whitish spots, which possibly are from salt deposits; and, on the underside of the slab, there appear to be stalactite-type deposits at some points. A search for records about the work, through design, documents, photos of its construction, or dialogue with residents, allows a more precise determination of the causes of the pathological manifestations found and can help in the formulation of appropriate maintenance interventions.

**Figure 4.** Pathological manifestations found in the analyzed bridge.

Therefore, as already discussed above, Figure 4 illustrates the fissure and efflorescence failures in the studied bridge. It is important to note that these pathologies found, even on a small scale, can significantly compromise the useful life of the artwork, as well as its safety.

In this context, it was found that the cracks may be due to errors in the design of structural elements, or else due to the lack of details of the project to guide the execution. Thus, as structural damage was noted in the bridge elements, the cracks found can be considered active with a small opening, assuming the worst-case scenario. The precise characterization of the active character of the fissure is made possible by monitoring its evolution over time. A repair intervention by injection of epoxy resin is proposed; injections must be made through traps spaced one and a half times from the depth of each fissure (Pereira et al., 2010).

As the manifestation of efflorescence in the structure is found in a humid place, with signs of infiltration in the areas adjacent to the salt deposit, epoxy-based paints can be used to solve the problem. It is a product with excellent resistance to chemical agents, water and atmospheric humidity, characteristics necessary for the pathology and structure in question (Pereira et al., 2010).
