Application of the GUT technique in pathological manifestations in reinforced concrete structures and their corrections

To the present study was carried out based on visual inspections and photographic records of the reinforced concrete structure of a single-family residence constructed in 1983 in the city of Passo Fundo, state of Rio Grande do Sul, Brazil. The single-family residence is composed by a reinforced concrete structure consisting of slabs, beams and columns, with a built area of 530 m². The residence has a total of four floors, the ground floor being used as a garage, and the rest as the living area of the residence. The many stages of this work were structured according to the flowchart of activities shown in Figure 1.

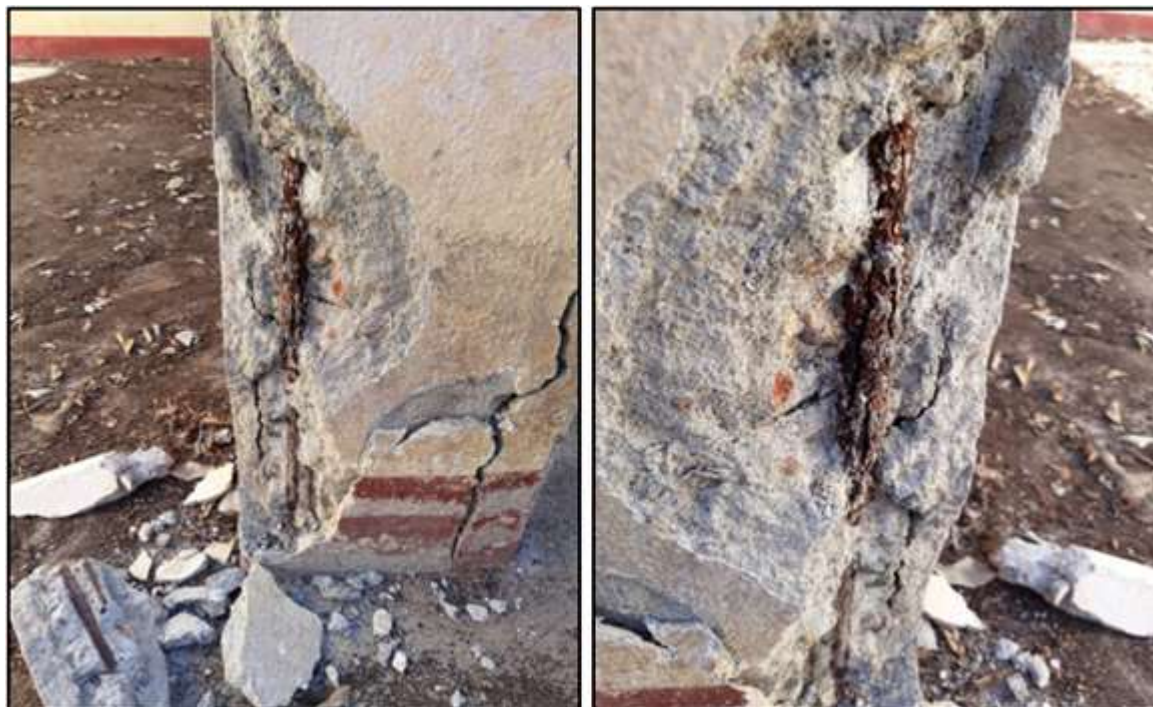
Figure 2: Reinforced concrete column on the ground floor of the building.

High deterioration of the steel in the structure was observed in Figure 2, as well as the loss of concrete section integrity of the structural part. In these conditions, the structure presents a serious risk of collapse, mainly because these are the columns of the ground floor, that support the load of other floors.

The non-observation of reinforcement covering is one of the main causes of pathological manifestations in buildings since the lack of this thickness of protection can facilitate the attack of chemical agents. These agents can attack the concrete, reducing its pH and accelerating the steel oxidation. Over time, this process will expand the section of steel, causing cracks and loss of section (Moreira, 2015; Silva Júnior et al., 2020). In this way, Brazilian Standard NBR 6118 (ABNT, 2014) establish a minimum reinforcement cover considering environmental aggressivity. The column reinforcement covering wasn't uniform and didn't meet the standard's requirements.

Thus, it is understood that the pathological manifestation occurred due to one or more of the following conditions: (I) the aggressor may have been incorporated in the concrete kneading process, or in the used steel bar, which was already in the corrosion process; (II) the concrete porosity, which can be related to the high water-to-cement ratio, and could result in the loss of compressive strength (Braga, 2010; Cirino et al., 2020). The reduction of compressive strength can facilitate the cracking process by overload (Carasek, 1996; Chaves, 2009; Cirino et al., 2020); or finally, (III) the wrong dosage rate of the concrete, not being enough to resist the building load, causing cracks and failure by the reduction of the compressive strength. The characteristics described for this situation, as well as their evaluation using the GUT technique, can be observed according to the summary presented in Table 4.

Figure	Pathological Manifestation	Parking column	
2	Advanced corrosion of the column reinforcement.	Possible causes:	<ul style="list-style-type: none"> • Concrete with high permeability and / or high porosity. • Incorporation of aggressive agents in the concrete matrix. • Low compressive strength.
		Origin:	<ul style="list-style-type: none"> • Project. • Execution.
		Symptoms:	<ul style="list-style-type: none"> • Loss of concrete adhesion. • Spalling of the concrete. • Steel corrosion. • Loss of reinforcement and concrete section.
		GUT: 640	G= 10; U= 8; T= 8.

As shown in Table 4, the identified pathological manifestation recognized an assessment: Total for Severity (10 points), high for Urgency (8 points), and high for Tendency (8 points), totaling a GUT of 640 points. As for the origin of the defects, it can be said that they could originate from the execution, because they did not pay attention to the correct cleaning of the parts, remove and identify the corrosive agents in the steel before its insertion in the structure; or due to project, in this case, considering that the structural calculator does not correctly consider the concrete strength F_{ck} .

As these are the same pathological manifestations both in columns, as in beams and slabs, the technique for correcting the structures to be used is similar for the different structural elements analyzed. The first step to correct the pathologies is to analyze the straining efforts on each structural part, to determine the support load of the structure's shoring. In the analysis of the GUT tool, it is possible to observe the need for priority correction for the slabs (1000 points), beams (800 points) and in sequence the columns (640 points).

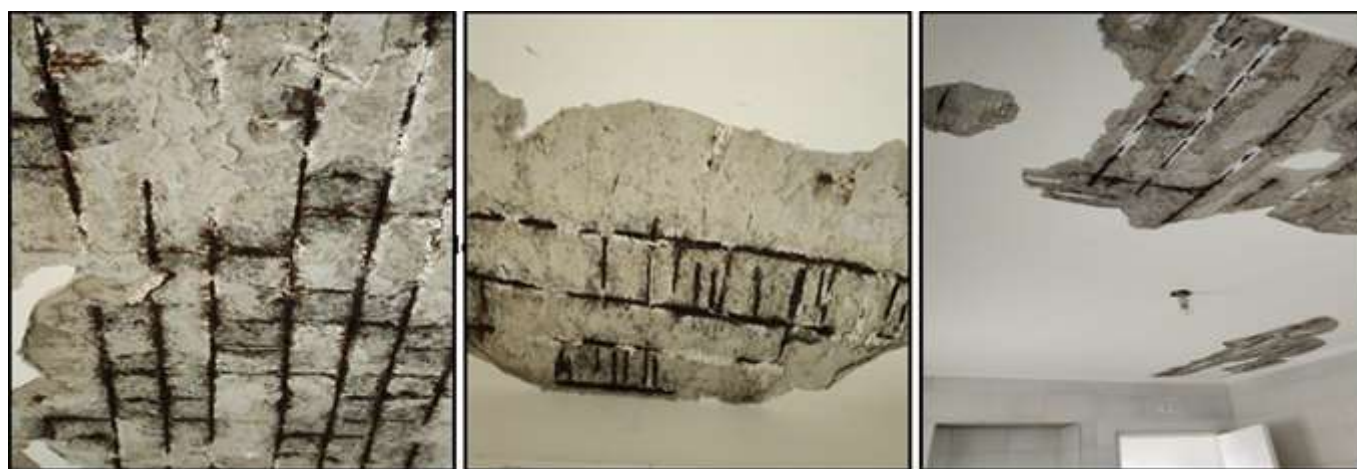
Figure 3: Reinforced concrete slab of the building.

During the inspection, was verified crumbling of concrete, in addition to the rebar's exposure in large regions of the slab (Fig. 3). And was observed that the concrete did not meet the national standards - NBR 6118 - regarding the minimum reinforcement cover for reinforced slabs, which is 25 mm in moderately aggressive conditions (urban areas) (ABNT, 2014). In

this way, the defect may have been caused by design, if the blueprints didn't present the minimum reinforcement cover specification or by execution, if were not used spacers during concreting process. Table 5 presents the possible causes and symptoms observed in the slab.

Figure	Pathological Manifestation	Parking column	
3	Advanced corrosion of the slab's reinforcement.	Possible cause:	<ul style="list-style-type: none"> • Concrete with high permeability and / or high porosity. • Incorporation of aggressive agents in the concrete. • Insufficient reinforcement coverage.
		Origin:	<ul style="list-style-type: none"> • Project. • Execution.
		Symptoms:	<ul style="list-style-type: none"> • Loss of concrete adhesion. • Spalling of the concrete. • Steel corrosion. • Loss of reinforcement and concrete section.
		GUT: 1000	G= 10; U= 10; T= 10.

The classification of the manifestation regarding the GUT technique was Total for Gravity (10 points), Total for Urgency (10 points), and Total for Tendency (10 points), totaling a GUT of 1000 points, according to Table 5. These considerations were based on the fact that the slab is submitted to bending moment as its main acting stress, therefore rebar steel is under tension conditions, and any failure of rebar may result in structural failure. This is proving to be in an advanced degradation's state; therefore, evaluations of Gravity, Urgency, and Tendency was considered Total for all the situations.

Moreover, the excessive humidity is another factor that could have caused these manifestations, due to the lack of waterproofing of the slab; however, this possible cause was ruled out of the investigation because the slab was not exposed to natural weathering and the residents did not clean the slab with excess water. Another factor to be considered is that no leak points were identified in the pipes.

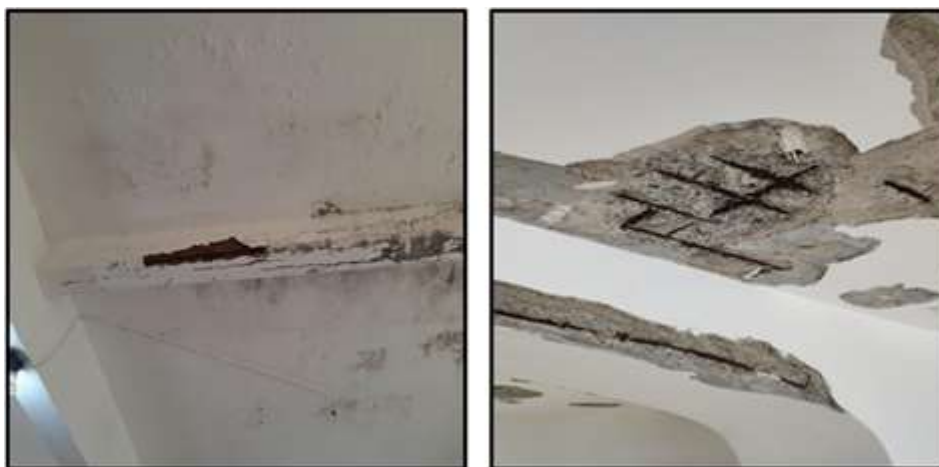
Figure 4: Reinforced concrete beams of the building.

In a visual inspection of the beams structure (Fig. 4), cracks were observed along with the element, as well as detachment of the concrete in the places of greater corrosion of the steel. In the beams, as well as in the columns, no flaws were observed concerning the reinforcement covering, therefore, in this regard, they were following the coverage guidelines of the national standard NBR 6118 (ABNT, 2014). The other pathological manifestations can be seen according to Table 6.

Figure	Pathological Manifestation	Parking column	
4	Advanced corrosion of the beam's reinforcement.	Possible cause:	<ul style="list-style-type: none"> • Concrete with high permeability and / or high porosity. • Incorporation of aggressive agents in the concrete. • Low concrete resistance to compression.
		Origin:	<ul style="list-style-type: none"> • Project. • Execution.
		Symptoms:	<ul style="list-style-type: none"> • Loss of concrete adhesion. • Spalling of the concrete. • Steel corrosion. • Loss of reinforcement and concrete section.
		GUT: 800	G= 10; U= 10; T= 8.

The classification of the manifestation regarding the GUT technique was Total for Gravity (10 points), Total for Urgency (10 points), and Total for Tendency (8 points), totaling a GUT of 800 points, according to Table 6. The considerations to be taken for the pathological manifestations observed in the beams are likewise those carried out in the previous structural elements.
