Fractographic analysis of two fractured removable partial denture metal frameworks

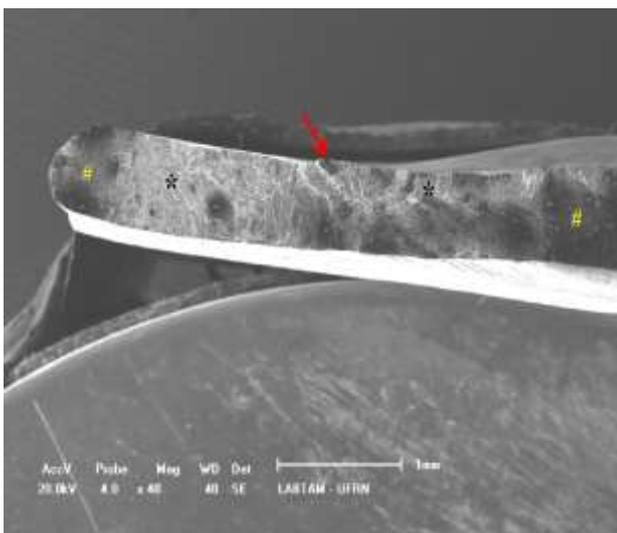
In Case A (Figures 1.1-1.4 and 2), the flutes between the minor and major connectors in the junction area are arranged to indicate the direction of propagation of the fracture from the region identified as the beginning of the failure (Figures 1.1 and 1.2). In two regions, the surface had a rough appearance created by microvoid coalescence, characterizing a ductile fracture or shear (Figure 1.3). However, in certain regions of the same piece, the surface showed lines or ribs, which is characteristic of a brittle fracture (Figure 1.4). Thus, the metal framework in Case A presented a mixed fracture.

Figure 1.1- Micrographs of the fatigue fracture area: (40x).

Subtitle: The red arrow indicates probable early failure.

* Indicates a ductile fracture region

Indicates a brittle fracture region (detachment area).

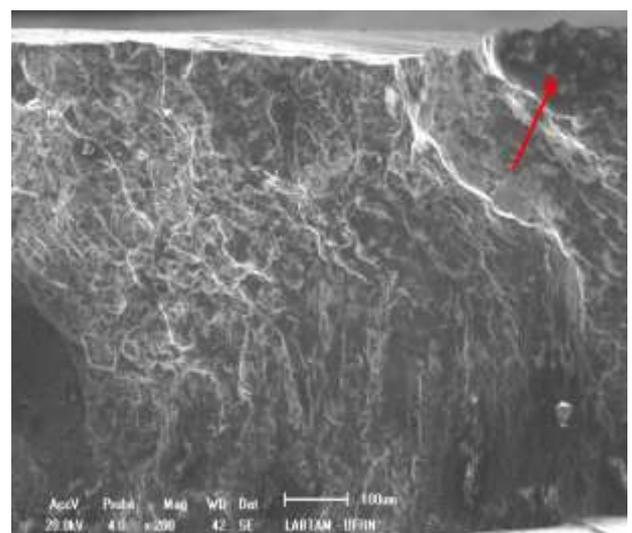
Figure 1.2- Micrographs of the fatigue fracture area: (200x).

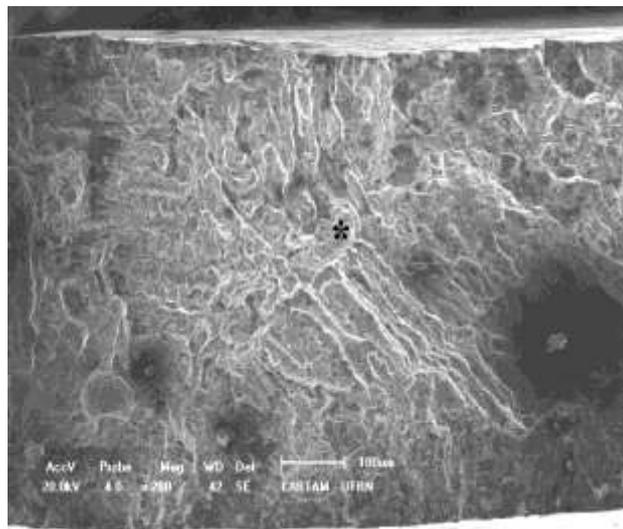
Figure 1.3- Micrographs of the fatigue fracture area: (200x).

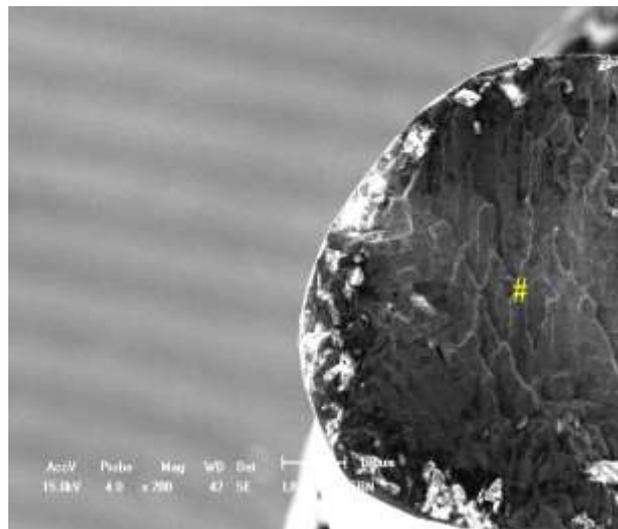
Figure 1.4- Micrographs of the fatigue fracture area: (200x).

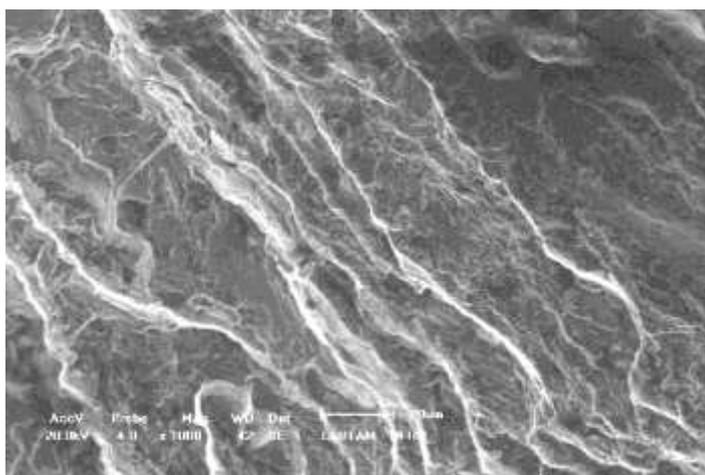
In Case A, fractographic analysis by SEM showed the fracture occurred due to fatigue (Figure 2), since the surface of the material presented 'beach marks', visible semi-elliptical lines characteristic of this type of failure.

Figure 2- Evident 'beach marks' that are characteristic of fractures caused by fatigue (1000x).

This could account for the results presented in Case A of this study, where a mixed fracture (ductile/brittle) occurred at the junction area between major and minor connectors. Evidence for material fatigue is most clear in the ‘beach marks’ at the fracture interface, characteristic of this type of failure, together with the patient’s continuous use of the RPD, which includes the repetitive movements of removal and insertion.

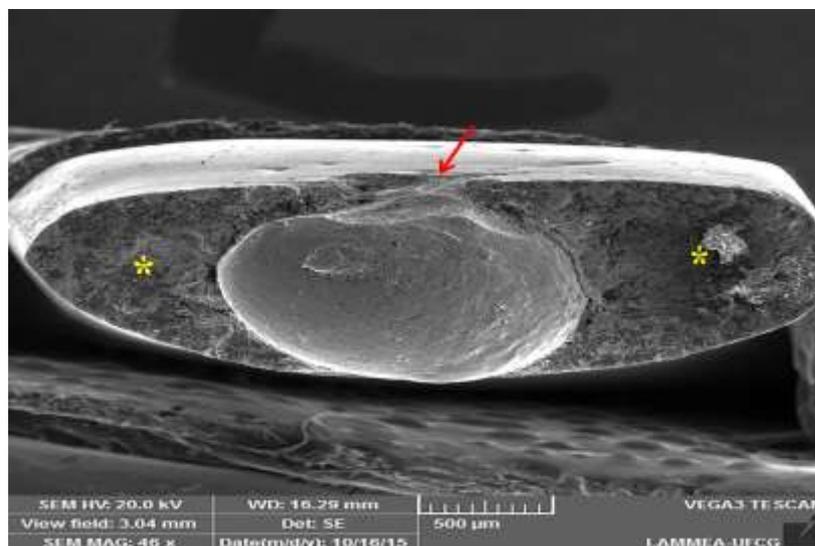
In Case B (Figure 3.1-3.3), the micrographs verified the origin of fracture and characteristics of a fragile or cleavage fracture, and the presence of an inclusion (Figure 3.1) in the center of the cross section of the larger connector. Figure 3.2 shows the mirror interface of 3.1 with a large defect in the center.

Figure 3.1- Photomicrograph of the fracture interface showing an inclusion in the center of the specimen (46x). The red arrow indicates probable early failure.

In Case B, the shape of the cross-sectional area was not sufficiently similar to that recommended by books for a lingual bar, and the micrographs showed that the fracture occurred due to possible errors during the casting process. Several hypotheses have been raised regarding the causes that led to the fracture. It seems likely that a certain amount of material was not completely fused, causing the formation of an inclusion. This may have occurred because the properties of the alloy were modified, including melting point, the alloy may have reused (Vallittu,1997), or the temperature was insufficient to complete the casting of the alloy. The last possibility could have been caused by furnace decalibration. It is also possible that the Prosthodontics technician released the alloy for injection into the feed channel before the metal was completely melted, leading to this type of defect.

It was not possible to determine the circumstances that caused the fracture in Case B, but the micrographs show an enclosed material in the metal framework, which promoted a local concentration of stress, thus reducing the mechanical properties of the framework. This type of localized defect facilitates rapid failure as soon as sufficient load is applied (Bates,1965).

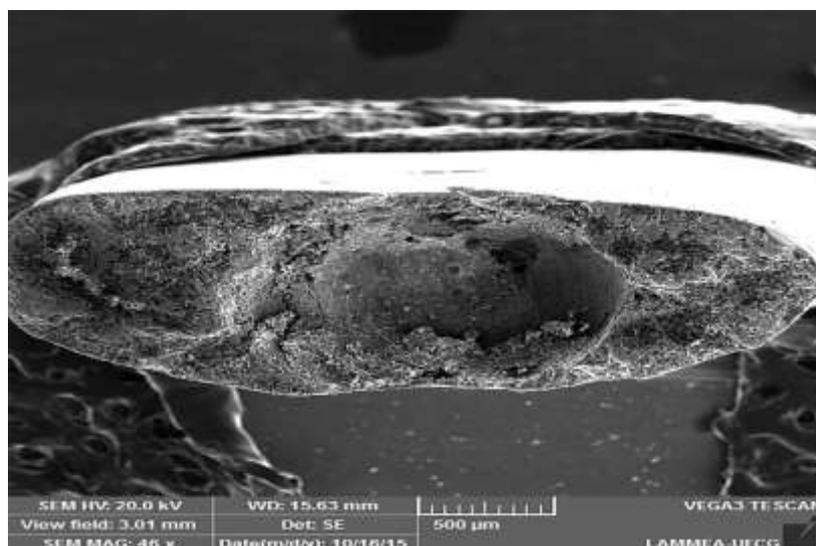
Figure 3.2- Photomicrograph of the mirror of 3.1, the fracture interface shows the void left by the inclusion (46x)

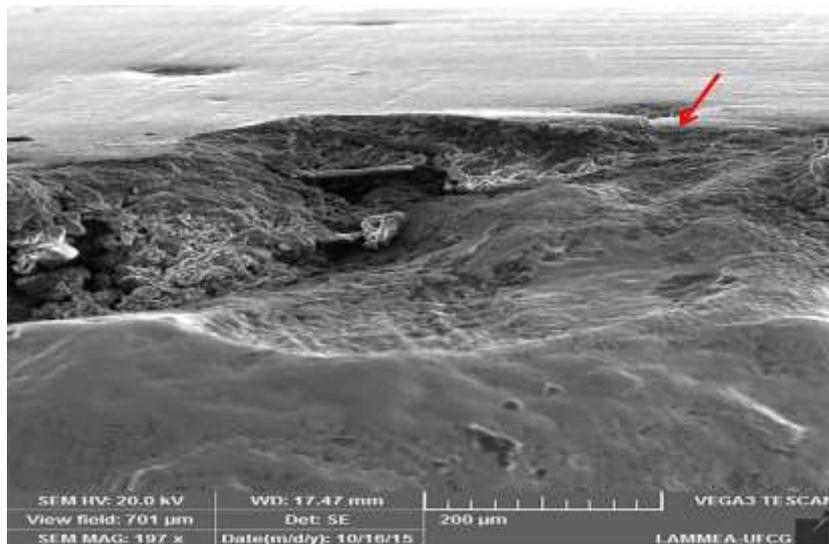
Figure 3.3- Photomicrograph showing a greater magnification of the likely beginning of the fracture, indicated by the red arrow (200x).

Subtitle: The red arrow indicates probable early failure.

* Shows regions that exhibit brittle fracture characteristics (detachment area).

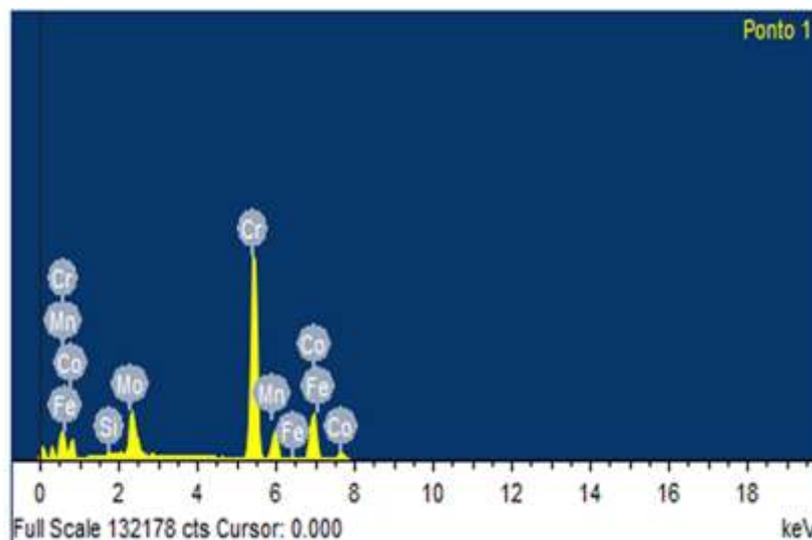
The EDS test, performed in the specimen of case B (Figure 3.1), showed predominant and characteristic peaks for Co and Cr (Figure 4), with a higher concentration of chromium, but showing the same concentration of the alloy the extremities.

Figure 4- Spectroscopy (EDS) of the center of the inclusion showing characteristic peaks for Cr and Co, the main elements of the alloys analyzed.
