Study of the pathological manifestations of the São Pedro and São Paulo Apóstolos Church

Therefore, this paper aims to present the results obtained in an analysis of the pathological manifestations identified in the São Pedro and São Paulo Apóstolos church, located in the city of Belo Jardim/PE, and to propose therapies for the anomalies presented.

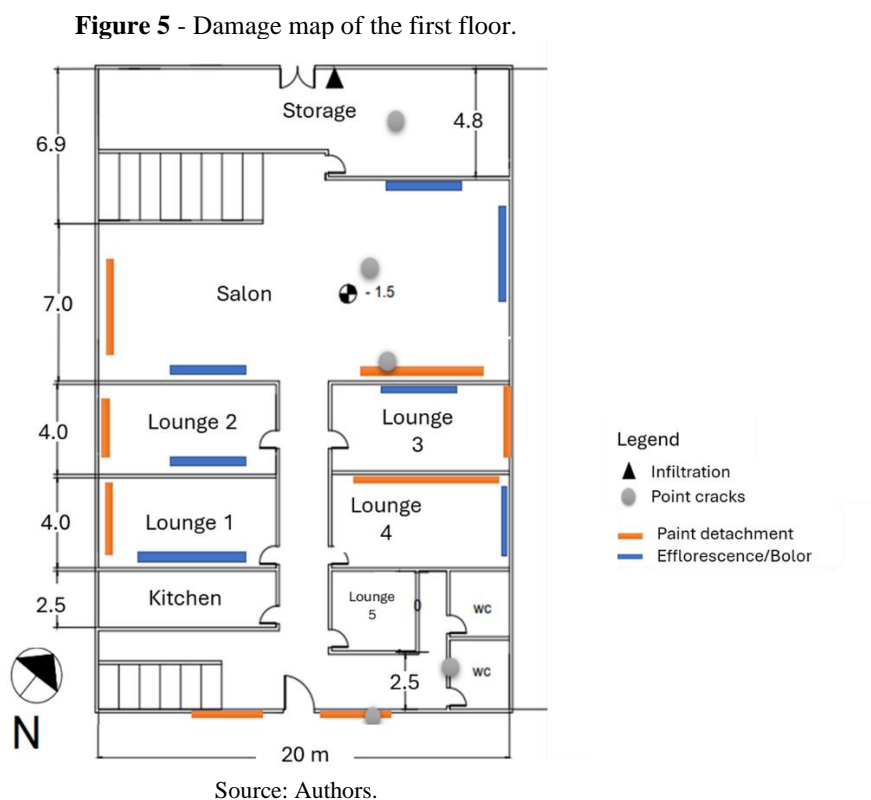
In summary, the main pathological manifestations identified in the building are efflorescence/smudge, detachment of paintwork, and occasional cracks. Figure 5 shows the damage map of the first floor. Stains caused by mold and efflorescence were the most common symptoms, as can be seen on the damage map (Figure 5).

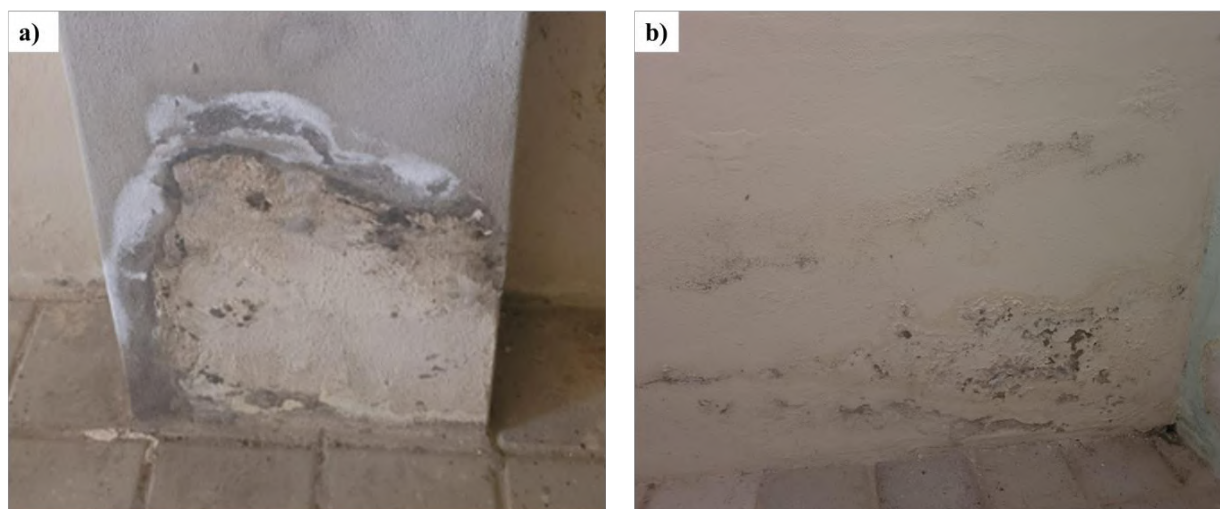
Figures 6a) and 6b) illustrate the stains from efflorescence and mold, respectively. The occurrence of mold was triggered by the high humidity retained in the rooms, resulting from the lack of waterproofing in the foundations and masonry, as well as the lack of ventilation and natural lighting. On the other hand, efflorescence was caused by the presence of soluble alkalis in the masonry components (bricks, sand, mortar, etc.) which are leached to the surface by the water present. These alkalis (also bases) react with carbonic acid and give rise to salts (calcium carbonate) which crystallize when the water evaporates (Figueiredo, 2005; Villain et al., 2007; Cascudo & Carasek, 2011; Ribeiro, 2014).

Figure 6 - (a) whitish spots (efflorescence) at the base of a pillar and (b) dark spots (mold) on the wall.

- The most common pathologies in the building stem from humidity, highlighting the need for solutions to address this anomaly. Options include installing new ventilation systems, enhancing natural light, and/or applying waterproofing.
- The pathological manifestations that pose the greatest risk to the lives of the people living in the building are the corrosion process present in the reinforcement of some pillars.
- The lack of preventive and corrective maintenance aggravates the difficulties mentioned above.

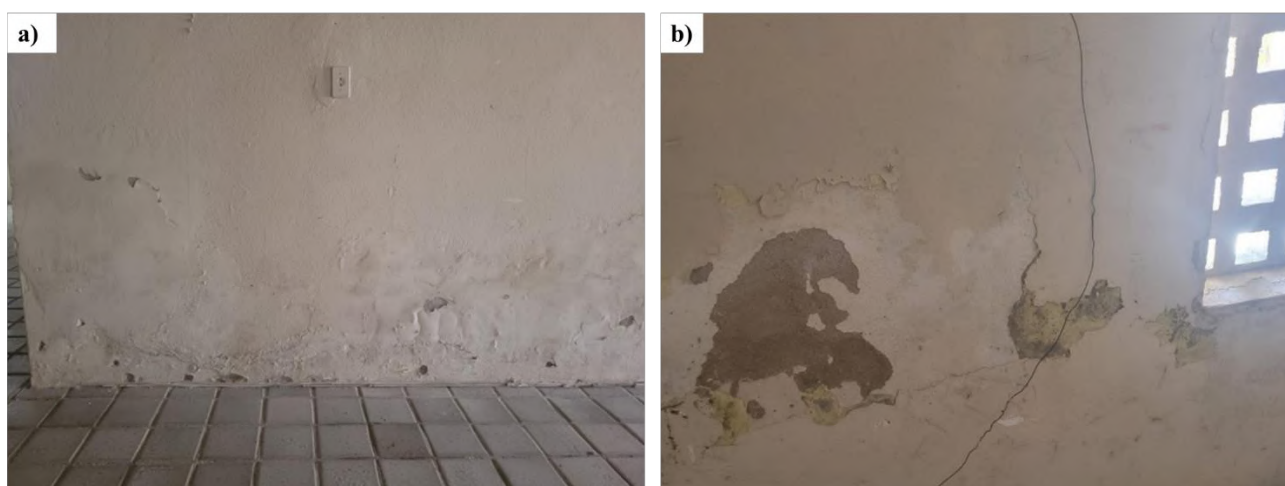
In all the rooms on the first floor and in the meeting room area, the paint was detached from the mortar coating layer (Figure 7 a and b). Some of these displacements are characterized by detachments with blistering, which indicates the separation of the plaster and render. As a result, in addition to the detachment of the paint, bubbles appear which increase progressively. On the other hand, the other displacements have the characteristics of detachment with powdering, in which the paint detaches together with the mortar.

Figure 7 - Displacement of the coating/paint system with a) blistering and b) pulverulence.

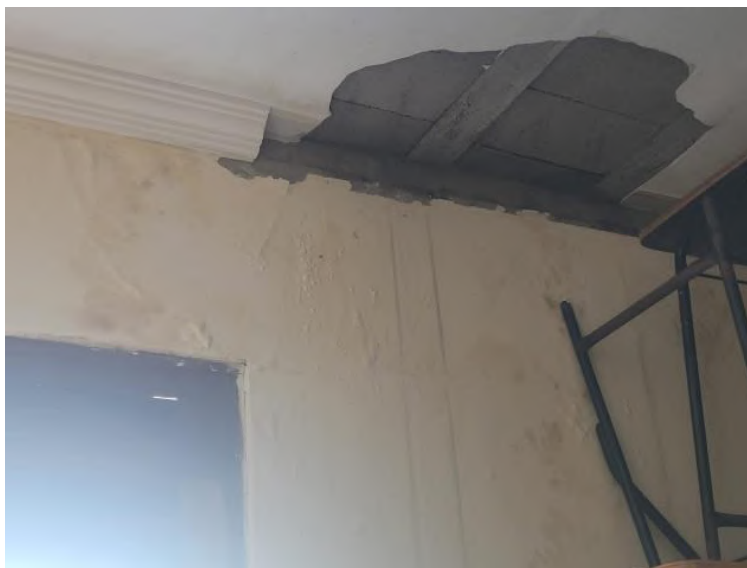
In addition to the pathologies mentioned above, the inefficiency of the building's roofing system was found in the warehouse, which was unable to provide effective protection against rainwater. This resulted in the deterioration of the plaster in the affected area since plaster is not resistant to the action of water. Figure 8 shows the infiltration and deterioration of the plaster in the warehouse.

Figure 8 - Infiltration and deterioration of the plaster ceiling.

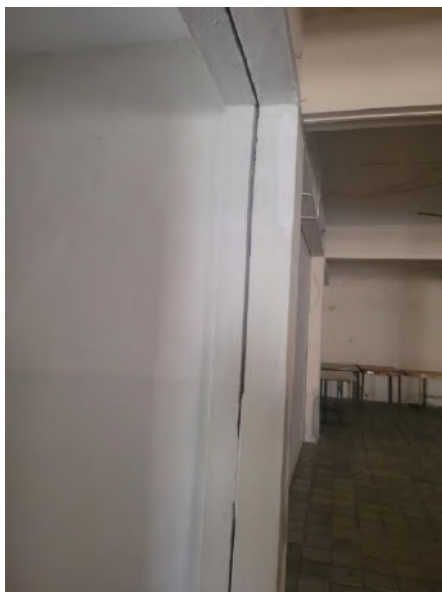
Due to the large size of the church, it was decided to build it in two stages, resulting in two buildings that were later interconnected. In this way, as shown in Figure 9, a visible separation can be found in the area at all the meeting places.

Figure 9 - Connecting the two buildings.

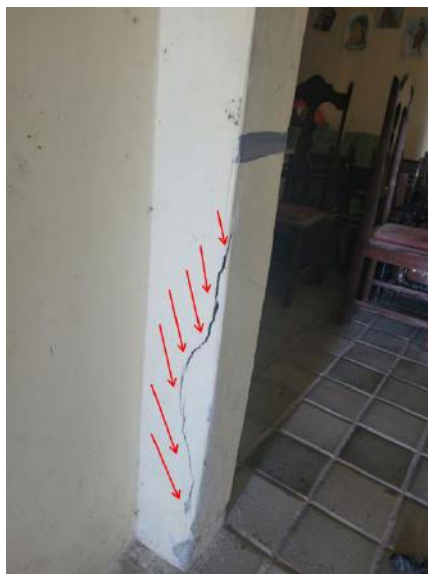
In addition, vertical cracks were identified in the pillars of the warehouse and the meeting room (Figure 10). These cracks are the result of corrosion of the reinforcement present in these structural elements. Corrosion can be triggered by the presence of carbon gas and/or chlorides and is primarily responsible for the degradation of reinforcement, making it more fragile and reducing its load-bearing capacity (Figueiredo, 2005; Villain et al., 2007; Cascudo & Carasek, 2011; Ribeiro, 2014). These cracks appear as a result of the expansion of the longitudinal bars due to the formation of rust, which consequently generates tensile stresses in the concrete.

Figure 10 - Vertical crack that follows the path of the longitudinal reinforcement.

Before correcting cracks, it is necessary to check whether they are active or inactive. Proper assessment of cracks can be done by monitoring them with cores. If the crack is inactive, with openings greater than 0.1 mm, Souza and Ripper (1998) suggest injecting epoxy resin.

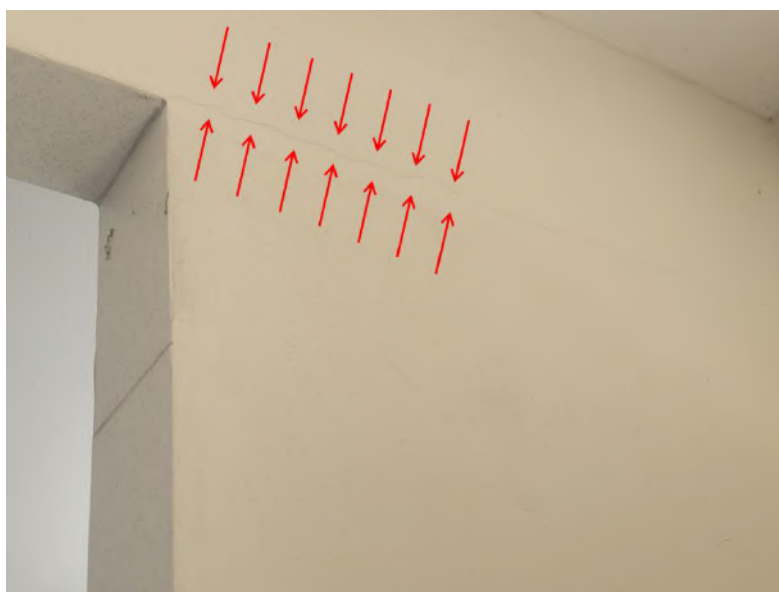
Figure 11 shows a crack in the upper corner of the bathroom door. The origin of this pathological manifestation is related to the absence or poor sizing of the lintel. When the lintel is absent or inadequately dimensioned, the stresses are not well distributed, resulting in the appearance of cracks at the points where the stresses are concentrated. These findings are in line with previous research (Chaves Neto; Mesquita; Martini, 2017; Leite et al., 2022) and emphasize the importance of proper sizing of lintels and/or counter-lintels as a preventive measure to avoid the appearance of cracks at the corners of openings.

Figure 11 - Crack caused by poor sizing of the lintel.

On the other hand, to correct the cracks located on the outside of the church, which are small and irregular, it is recommended to apply mastic to the affected area. In the case of cracks resulting from the lack or inadequacy of lintels and counter-lintels, it is advisable to install electro-welded metal mesh, with a square mesh opening of 25 mm and with a 25 cm transposition on each side of the opening, as recommended in the specialized literature (Sena, Nascimento & Nabut Neto, 2020; Thomaz, 2020). A schematic for this type of repair can be seen in Figure 13.

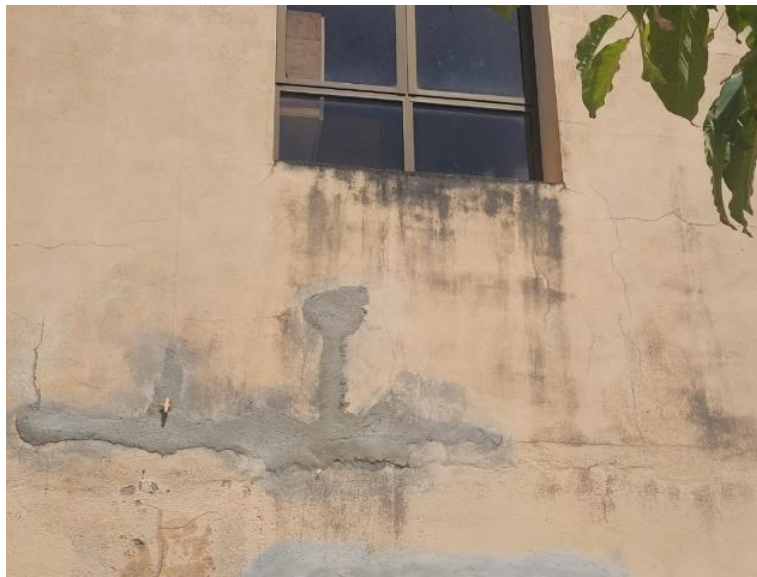
On the outside of the church, as shown in Figure 12, irregular cracks resembling spider webs can be seen. Cracks with these characteristics are commonly caused by expansion or shrinkage in the mortar's hardening phase (Thomaz et al., 2009; Thomaz, 2020).

Figure 12 - Some cracks on the outside of the church.
