Characterization of the useful life and structural performance of a reinforced concrete bridge in the City of Correntes-PE

Received: 04/01/2021 | Reviewed: 04/10/2021 | Accept: 04/15/2021 | Published: 04/27/2021

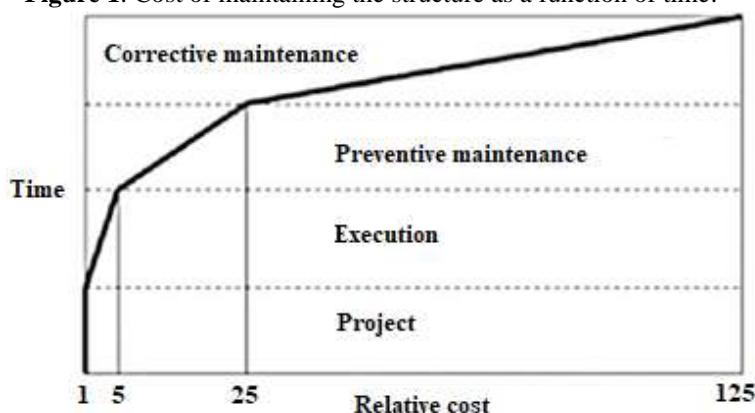
Figure 1. Cost of maintaining the structure as a function of time.

As shown in Figure 1, when the changes are made in the design phase, this cost is right 1, as it is still in the planning phase. When the adjustments are made in the stages of execution, preventive and corrective maintenance, these values correspond to 5, 25 and 125, respectively.

Therefore, in terms of maintenance promotion, it is evident the need for changes to be preferably made in the design phase, as the structure is still in the planning process and the costs of changes will be considerably lower when analyzed and carried out in the other stages. Thus, sooner the pathology is diagnosed and treated, the lower the cost and the more advanced the work or the damage evolves, the greater the cost for recovery, growing exponentially.

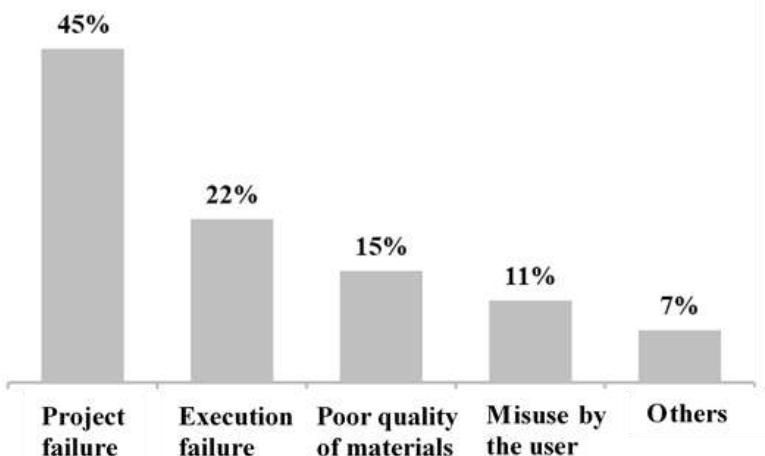
Figure 2. Causes of pathologies;

As can be seen (Figure 2), almost half of the problems identified were linked to project failures, followed by execution failures and other factors. There is a core of thinking about obtaining this data, especially when it comes to design and execution failures.

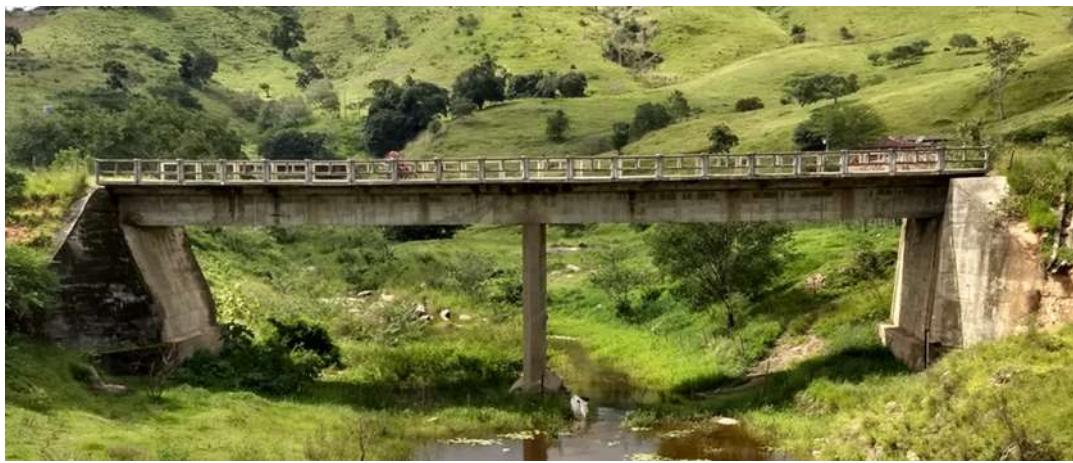
Figure 3. Bridge in the city of Correntes-PE.

The bridge shown in Figure 3 is approximately 40 m long and 9 m wide, with a height of approximately 12 m. It was not possible to access the project's structure. Sclerometry tests were performed to determine the surface hardness of the concrete, in order to estimate the characteristic strength. This test was carried out according to the guidelines established by NBR 7584 (ABNT, 2012), with the use of a reflection sclerometer.

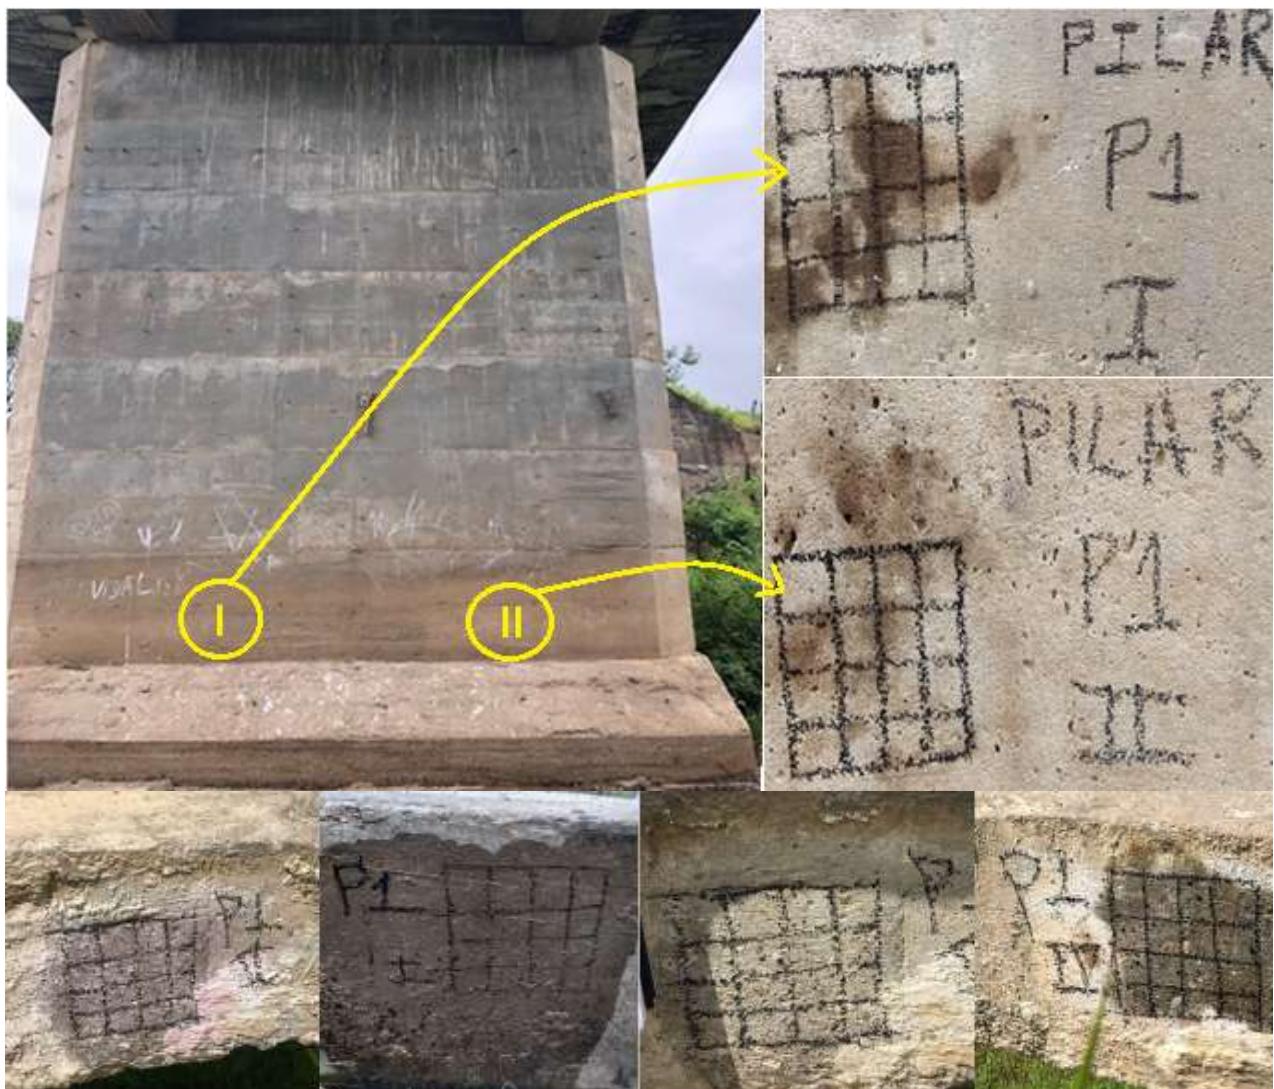
In Figure 4, the indicated locations represent the positions of the sclerometry tests. These tests were carried out on the central pillar of the bridge.

Figure 4. Conducting sclerometry tests on the catwalks and central pillar.

It is noteworthy that access to this central pillar was difficult, given a certain depth of the river level. Porosity points were also found at the test sites. After performing and collecting data from all points, the values were categorized and treated according to Table 1.

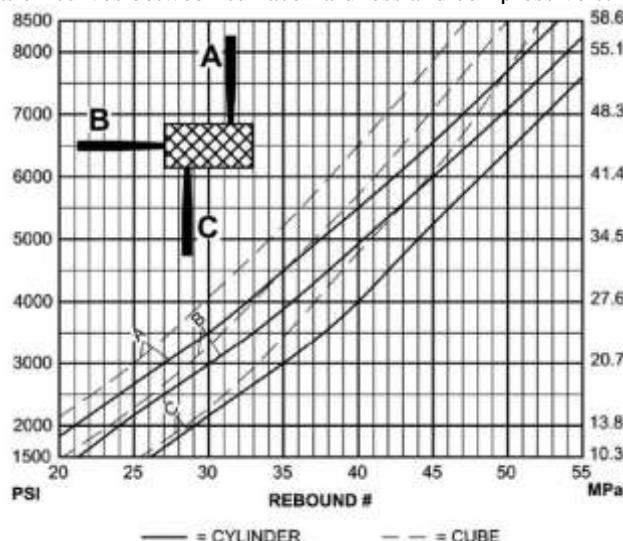
Figure 5. Correlation curves between surface hardness and compressive strength of concrete.

For this study, the sclerometer was used horizontally, therefore, the curve used was that of position A. Based on the correlation between surface hardness and compressive strength, was determined the compressive strength (Table 2).

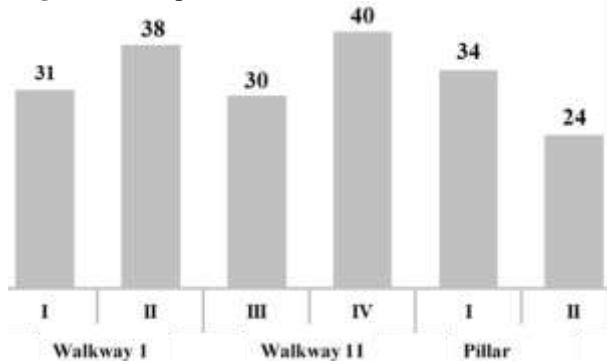
Figure 6. Comparison of resistances between elements.

Based on the results found (Table 2 and Figure 6) readings performed, different resistances were obtained. It is possible to categorize several possible causes for such events, from the concrete production stage to the conditions of launching, densification and curing. Also, the porosity at the test site may have interfered with this data discrepancy.

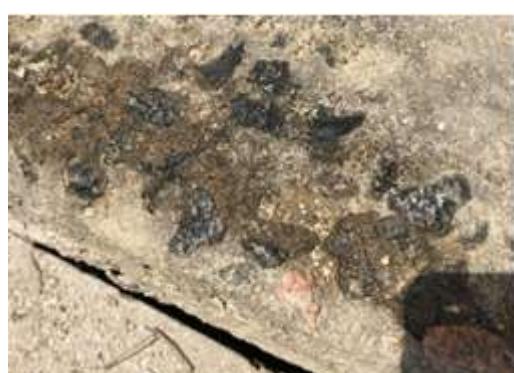
Figure 7. Carbonated area.

It can be identified (Figure 7) that upon contact with the phenolphthalein solution, the surface soon became colorless, thus demonstrating that it is already with low alkalinity, proving that it is already in an active carbonation stage.

It should be noted that it was not possible to carry out the test in more depth in the concrete, until the contact with the reinforcement for spraying the solution, due to authorization and logistics issues. It is emphasized the need for additional tests with respect to carbonation to more accurately identify the depth of carbonation. Finally, in terms of identifying efflorescence in the structure, points of high incidence were not identified, with only a few points standing out, as shown in Figure 8.

In terms of carbonation, it was identified that part of the structure was already carbonated, requiring better deepening, more in-depth tests and also monitoring of structural elements, in order to promote solutions in the short, medium and long terms. Regarding the effects of efflorescence, few points were identified. There are also no problems with exposed reinforcement with corrosion problems.

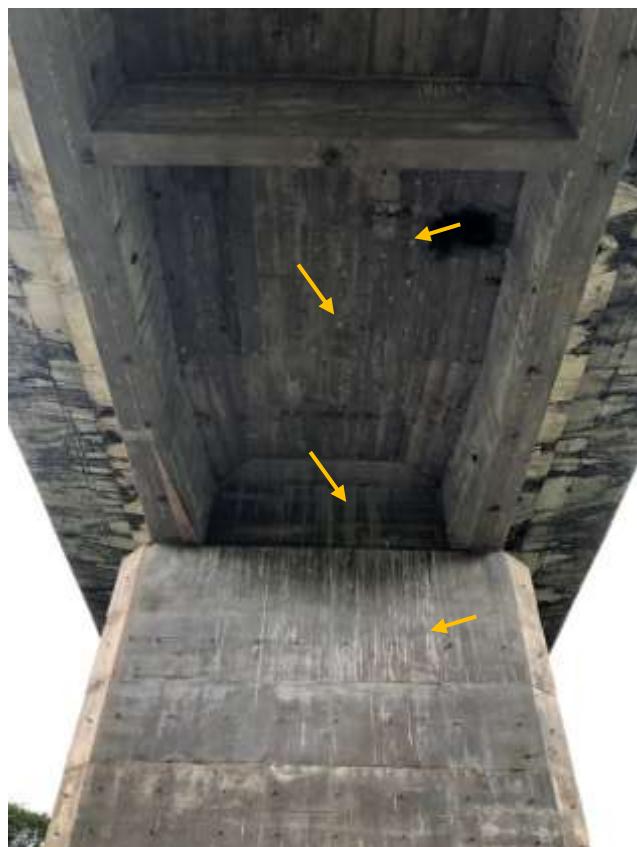
Figure 8. Efflorescence incidence spots.

As can be seen in the figure above, some points of incidence of efflorescence were observed. In addition, no exposed reinforcement points with corrosion problems were found. Thus, due to the current conditions of the bridge, even with little maintenance, it is considered that the bridge is in a regular state regarding its performance.

In general, the bridge has, until then, been in a regular state of performance. However, the need to carry out continuous inspections with preventive maintenance is emphasized, in order to avoid future damage and prolong the useful life of the analyzed bridge.
