Organizational factors: a case study of the cost-benefit of implementing control measures in precast structure constructions

Given the above, this paper aims to demonstrate through a case study the implementation of systematic inspection systems in construction sites as a risk management strategy of the company in the identification of deviations, as well as to propose organizational solutions of low implementation cost. In addition, it demonstrates the cost-benefit of investing in organizational solutions for occupational safety on the protection of the enterprise's capital.

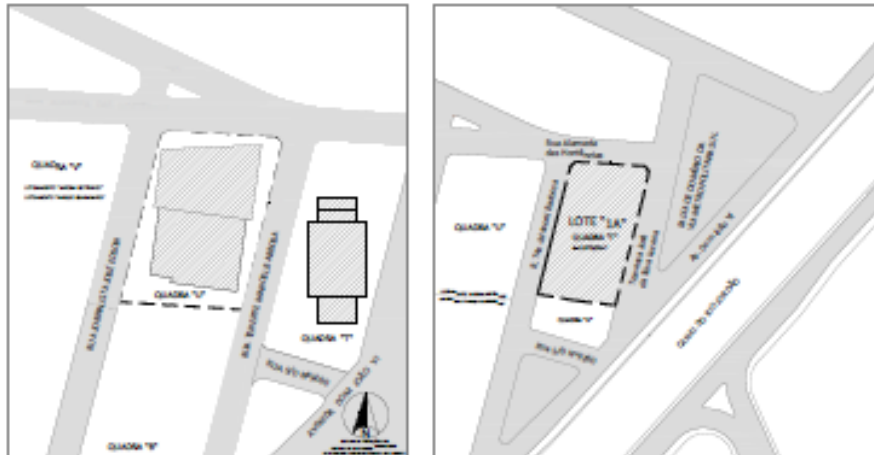
Figure 3 - Schematic of the educational enterprise.

The architectural design of the development includes two building units named "T block " and "U block ". The T block has 3 floors, being the ground level for access and two levels of rooms. The U block has 5 floors, with a semi-underground level for garages, a ground level and three levels of rooms.

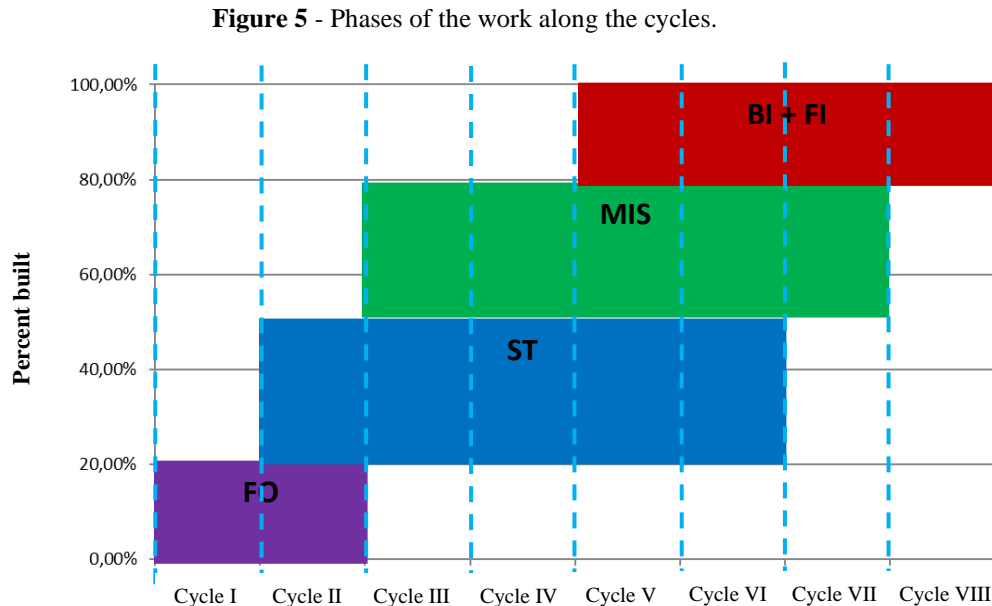
The chart in Figure 5 was developed to illustrate the evolution of the percentage of the construction work built over the audit cycles performed. With it, it is possible to indicate the types of activities that were found at the time of the safety inspection of the project.

According to Figure 5, the 8 cycles of inspections corresponded to the complete monitoring of the project. For Freitas et al (2021) works executed in 8 months are considered fast and have challenges in the management process. The Quantitative Indicator reported in Figure 6 presents the frequency of incidence of non-conformities. The quantitative indicator showed uniformity in relation to the number of disagreements, with a maximum point with 14 disagreements in Cycle IV, a period with a large number of contractors on site, and a minimum point with six disagreements in Cycle I, due to the construction still being in the beginning, and consequently, the reduced number of activities and employees. Regarding the SIR, the indicator shows that it had an increasing trend until it reached its maximum value and then suffered a decline until the end of the site visits. For a better view of the site performance in relation to Disagreements and Serious and Imminent Risks - SIR, Figure 6 was generated without the compliance data.

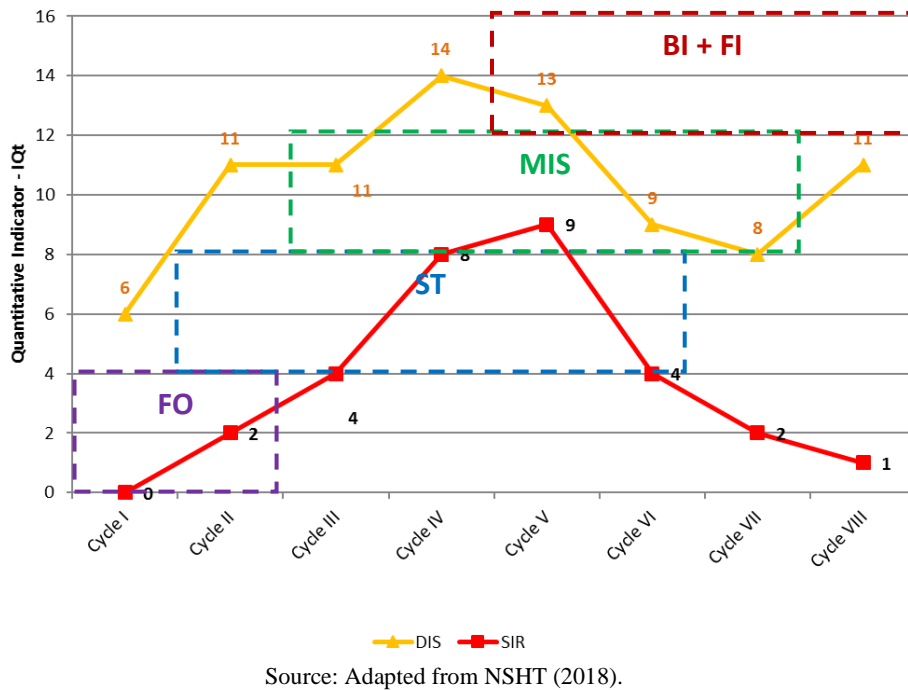
Figure 7 - Quantitative indicator combined with construction phases.

Analyzing the graph in Figure 7, we see that the highest incidence of normative deviations occurred in Cycles IV and V. This is justified by the fact that during these cycles there was a larger amount of activities to be performed on site, involving the phases of Structure (ST), Masonry and Internal Sealing (MIS) and the beginning of the Building Installations and Finishing

(BI+FI), the latter precisely in the cycle with the highest incidence of irregularities (22). According to Soares Júnior et al (2021), the more activities being performed, the greater the number of workers involved, causing the amount of causes for possible accidents to also be greater, making it normal to have an increase in the amount of irregularities found in OHS audits. Therefore, the drop in the number of serious and imminent risks (SIR) contemplated during the technical visits is due to the measures that were requested to be implemented in the reports of previous audits and the gradual decrease of activities being carried out on the work fronts and the number of staff working at the site. This fact is justified by observing the drop in the number of irregularities as soon as the activities of the Structure phase (ST) of the works were terminated.

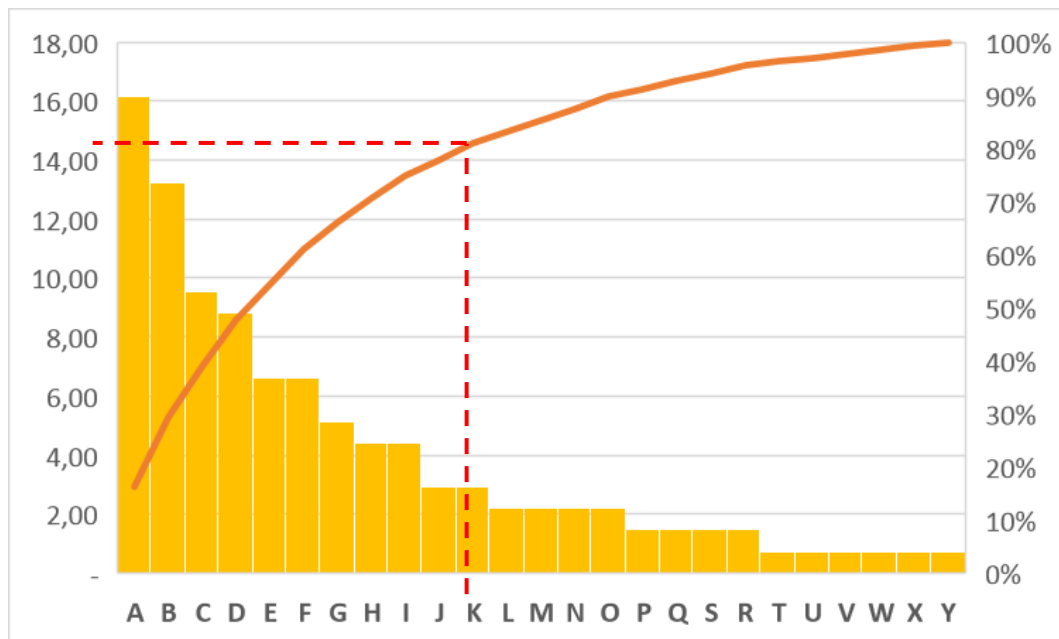
Figure 8 - Pareto distribution for qualitative indicator of disagreements.

A: ITEM 18.4 - Living area; B: NR-6 - PPE; C: ITEM 18.13 - Protective measures against falling from height; D: ITEM 18.12 - Ladders, ramps and walkways; E: ITEM 18.15 - Scaffolding; F: ITEM 18.21 - Electrical installations; G: ITEM 18.7 - Carpentry; H: ITEM 18.14 - Movement and transportation of materials and persons; I: ITEM 18.26 - Fire protection; J: NR-10 - Safety in Services with Electricity; K: ITEM 18.29 - Order and cleaning; L: ITEM 18.3 - PCMAT; M: ITEM 18.8 - Steel Frames; N: ITEM 18.24 - Storage and stocking of materials; O: ITEM 18.27 - Safety signs; P: NR-12 - Safety at Work in Machinery and Equipment; Q: ITEM 18.6 - Excavations, foundations, and blasting rock; R: ITEM 18.22 - Miscellaneous machinery, equipment, and tools; S: NR-18 - Annex IV; T: NR-17 - Ergonomics; U: ITEM 18.23 - Personal Protective Equipment - PPE; V: ITEM 18.30 - Hoardings; W: NR-22 - Safety in Mining; X: NR-24 - Sanitary and Comfort Conditions in the Workplace; and Y: NR-34 - Working Environment and Conditions in the Naval Construction, Repair, and Dismantling Industry. Source: NSHT (2018).

According to Figure 8, it is possible to see that the highest frequency of disagreements is related to ITEM 18.4 - Living Area, totaling 16.18% of the occurrences, followed by Personal Protective Equipment - NR 06 (13.24%) and ITEM 18.13 - Protection Measures Against Falls from Height (9.56%).

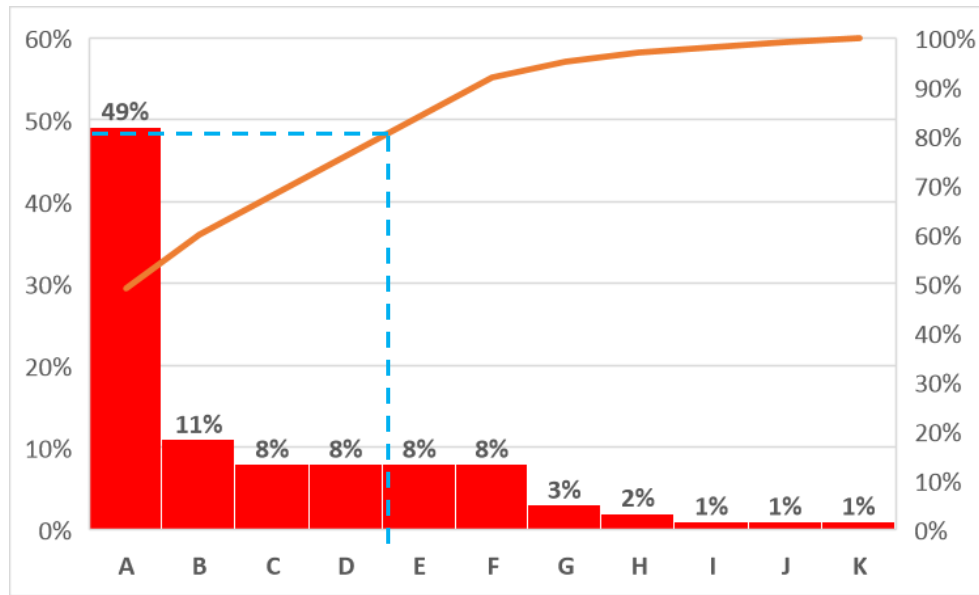
Figure 9 - Pareto distribution for qualitative SIR indicator.

A: ITEM 18.8 - Steel frames; B: ITEM 18.15 - Scaffolding; C: NR-6 - PPE; D: ITEM 18.11 - Welding and hot cutting operations; E: ITEM 18.13 - Protective measures against falling from heights; F: ITEM 18.23 - Personal protective equipment - PPE; G: NR-18 - Annex IV; H: ITEM 18.24 - Storage and stockpiling of materials; I: ITEM 18.6 - Excavations, foundations and rock dismantling; J: ITEM 18.21 - Electrical installations; and K: NR-35 - Work at Height.
Source: NSHT (2018).

Analyzing the data presented in Figure 9, it is possible to verify that the highest amounts of SIR found are related to Item 18.8 - Steel Frames, with 49% of occurrences, and then, Item 18.15 - Scaffolding, representing 11% of the total.

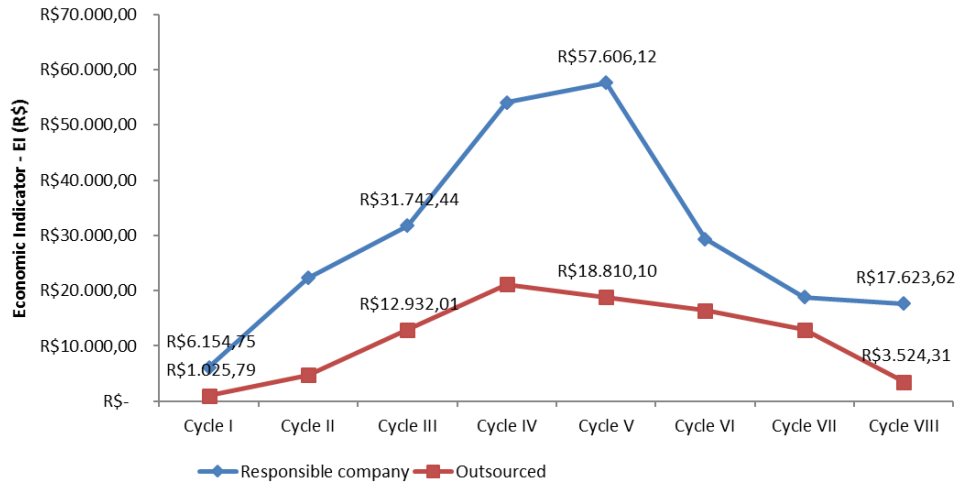
Figure 10 - Economic Indicator Responsible Company x Outsourced Companies.

It is possible to see that the liability of the Responsible Company (RC) is directly proportional to the liability of the outsourced companies. This situation is justified by the proportional number of employees of the RC and third parties in all phases of the work. It is possible to verify that, as well as the SIR curve in the IQt, from Cycle I to Cycle V there was a growth in the Economic Indicator, both of the RC and the contractors, with the highlight for a more accentuated growth of the RC.

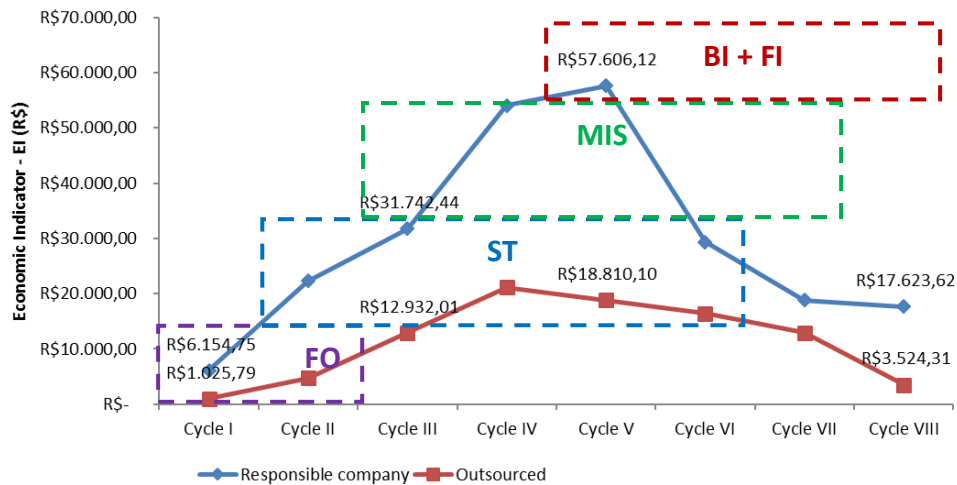
Figure 11 - Economic Indicator combined with construction phases.

In the same way as was done in Figure 7, Figure 11 indicates the phases of the work during the EI values over the safety audit cycles.

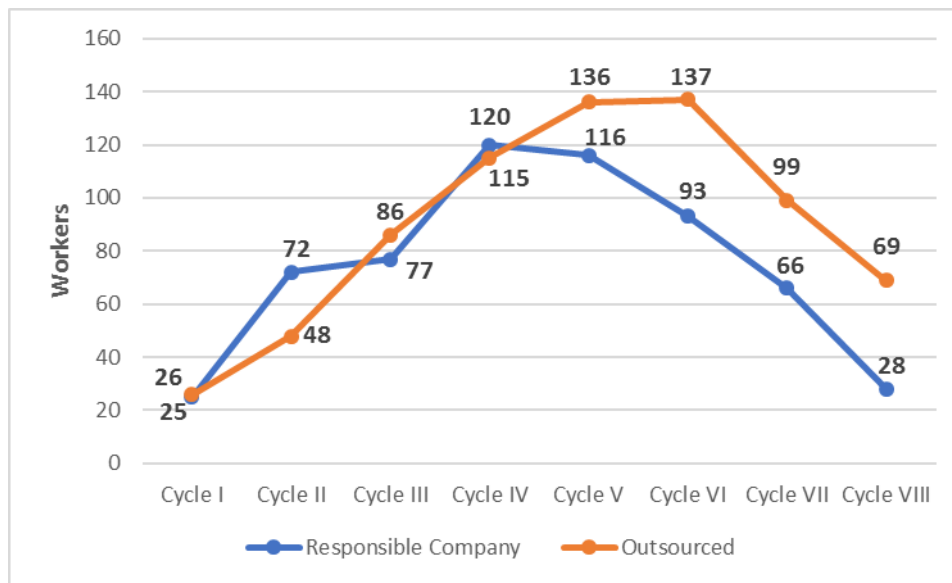
Figure 12 - Evolution of the workforce on site.

With regard to the number of employees involved in the construction work, according to Figure 12, the RC only presented a higher number of employees than the outsourced employees in Cycles II and IV. Confirming the important role of outsourced employees in the EI data.

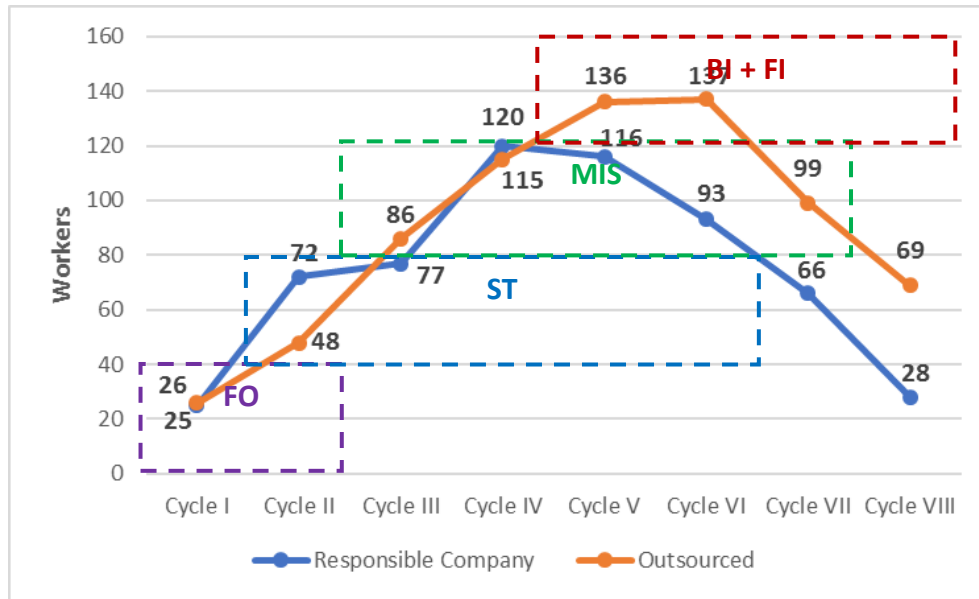
Figure 13 - Evolution of workforce combined with the phases of the project.

The more service fronts are opened at the construction site, it is natural that more workers are involved in the work (Freitas et al., 2021). Figure 13 shows that as new stages were starting and new service fronts were opening, the total workforce on the site followed this increase in the number of activities to be performed at the site. Just like the graphs in Figures 7 and 11, the highest values occurred in Cycles IV and V, with 235 and 252 workers in total, respectively. Confirming the influence of the number of workers in the occurrence of non-conformities cited by Soares Júnior et al. (2021).

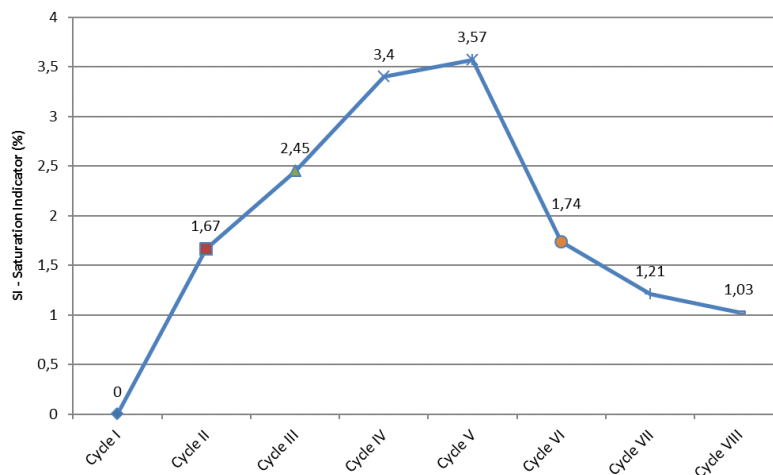
Figure 14 - Saturation Indicator.

The Qualitative and Economic Indicators shown above present an overview of the work in relation to the requirements inspected by the Ministry of Labor. It is noteworthy that situations that offer risk to the lives of workers, besides being an item with high liability of fines, also causes stoppages, embargoes and interdictions and can cause high economic losses (Fernandes et al., 2021). Based on this information, the Saturation Indicator presented in Figure 14 represents the number of SIR found, throughout the audit cycles, for a group of 100 workers.

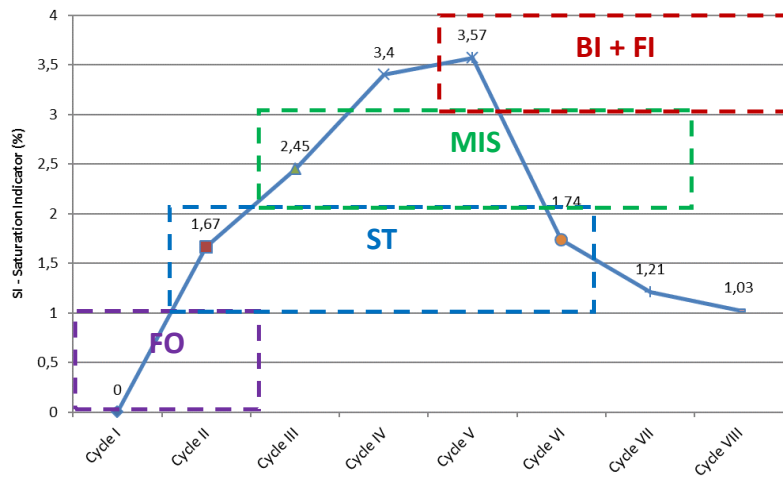
Figure 15 - Saturation indicator combined with the stages of construction.

According to Figure 15, it is possible to see that there was an oscillation during the construction period, as well as the curve of the SIR in the IQT. Until Cycle V there was an increase in the saturation indicator, corresponding to the peak of 3.57 SIR/100 workers, this shows that the conditions with potential to cause serious and fatal accidents (SIR) increased until that month. From September on, a decrease in the saturation index was observed, consequently, the number of SIRs decreased, causing a lower potential of serious and fatal accidents, reaching 1.03 SIR/100 workers in December.

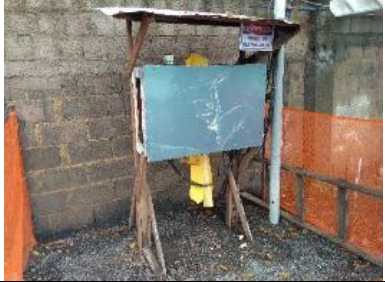
Non-conformitys	BEFORE	AFTER
Switchboards without signalling and safety interlocks

The operational measures presented in Table 2 prevent the company from being fined in the event of an infraction notice. Analyzing each correction implemented according to Table 1, the company needed to disburse a total amount of R\$ 2,011.47. If it were to receive labour fines for the non-conformities raised, it would pay the amount of R\$ 32,216.00, according to the regulatory standard on Inspection and Penalties (NR-28, 2020). Therefore, the cost of safety corresponds to 6.24% of the capital exposed in fines.

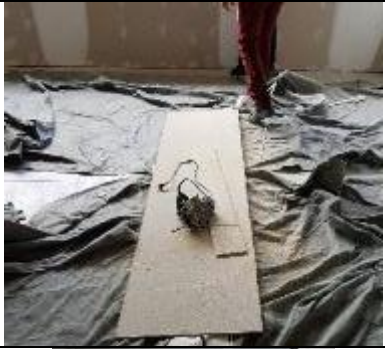
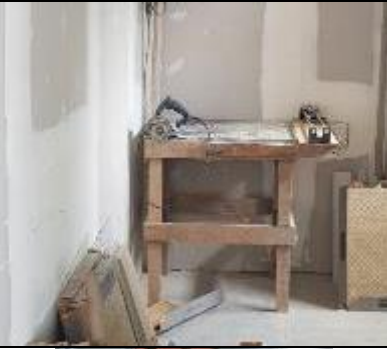
Cutting materials without a suitable workbench

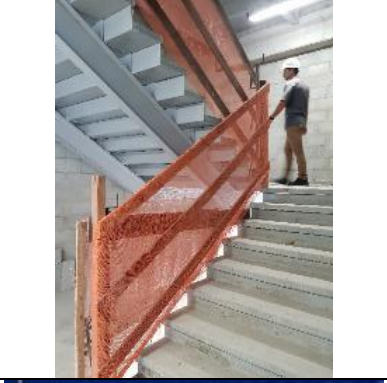
Places with risk of falling without collective safeguards

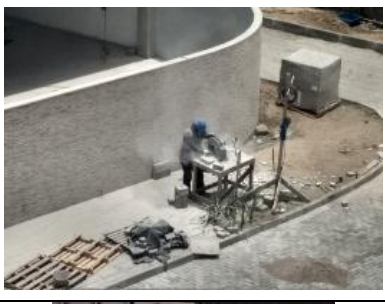
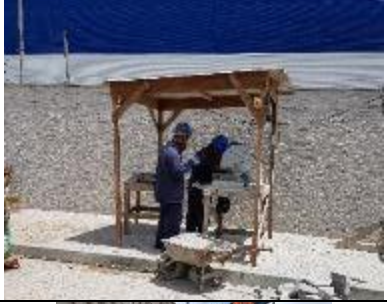
Working under the action of bad weather

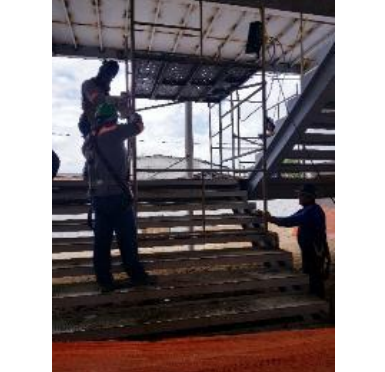
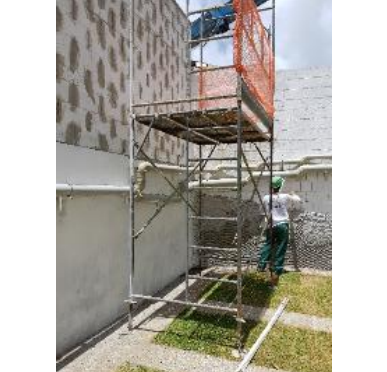
Scaffolding not in accordance with the projects

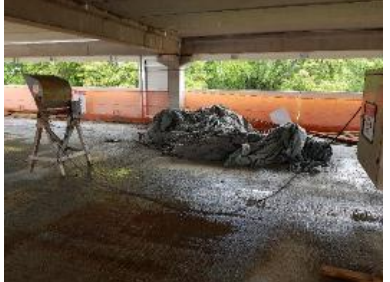
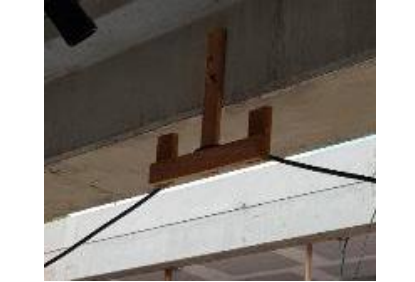
Low wiring subject to mechanical impacts

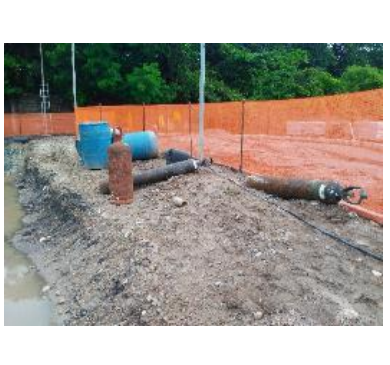
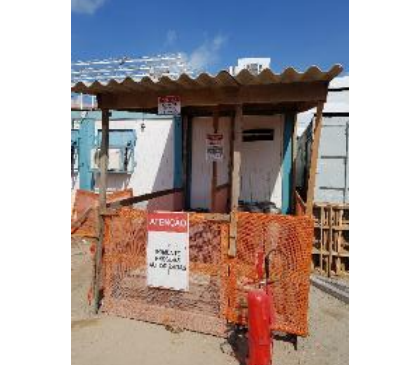
Gas cylinders and flammable materials without adequate place for storage
