Comparative analysis of the state of conservation of social housing facades in

Pelotas/RS

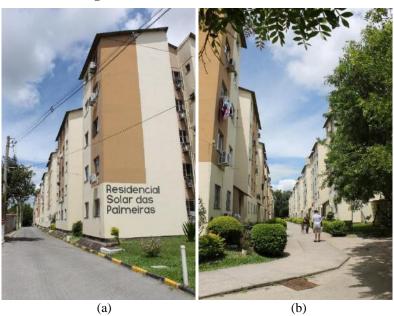
Figure 1: Residencial Solar das Palmeiras.

Vehicle and pedestrian access to the complex takes place along the public road, with two gates, a guardhouse, and a gate. The bike rack has no cover and is located next to the guardhouse, along with the mailboxes and waste collectors. The parking lot is located at the end of the plot, with spaces for 152 cars. The space for motorcycles is attached to that for vehicles, but closer to the blocks. Figure 1a and 1b show views of the residential from the vehicle and pedestrian access roads, respectively.

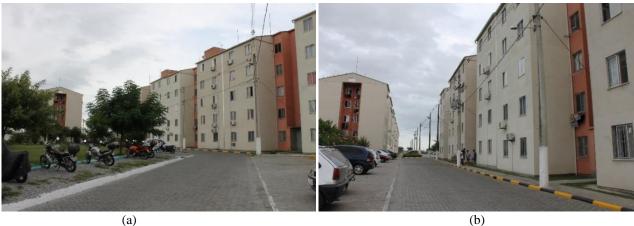
Figure 2: Residencial Paraíso.

Residencial Paraíso was delivered to residents in August 2007, under the PAR SPECIAL modality. Figures 2a and 2b contain general views of the blocks, access roads, green areas, and spaces for parking vehicles. According to Azevedo and Guerra

(2008), the construction system used in the set consists of external and internal vertical seals of structural ceramic blocks with dimensions of 14x19x29 cm, and the external finish consists of roughcast, plaster, sealer, and acrylic paint. In the internal finish, only sealer and pigmented texture were used. The external frames are in aluminum and the internal ones in wood. The floors were built in pre-molded slabs, with the upper face (floor) of the bedrooms being simply polished, while ceramic tiles were applied in the other rooms. The underside of the slabs (ceiling) was not coated, thus remaining in exposed concrete. As for the foundations, excavated concrete piles were adopted. The roof consists of a wooden structure and fiber cement tiles.

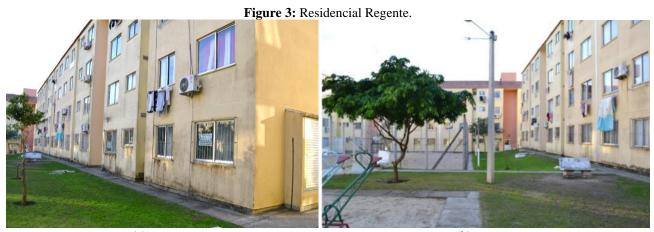
The Residencial Regente are four-story housing projects belonging to the PAR Normal modality and were delivered to the tenants in January 2006. Figures 3a and 3b contain general views of the blocks. The construction system of the set consists of structural masonry of ceramic blocks with mortar coating. The floors were built on pre-molded slabs supported on the mooring belt made with a channel-type ceramic block filled with grout and the foundations are excavated concrete piles. The roof is composed of ceramic tiles on a wooden structure supported by masonry props on the roof slab. The set has a 15cm eaves and does not have a gutter for collecting rainwater. The external frames are made of aluminum, which are closed with transparent glass framed in the aluminum profiles. The windows do not have opaque closures. The drip trays were made of concrete and painted with the same paint as the masonry.

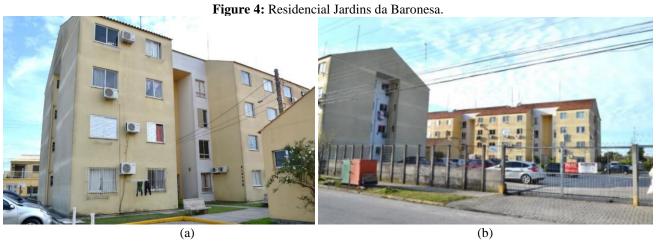
Residencial Jardins da Baronesa consists of four-story buildings delivered to tenants in December 2005, belonging to the PAR Normal modality, shown in Figures 4a and 4b. The residential was built in structural masonry of ceramic blocks coated with mortar. The floors were built on pre-molded slabs supported on the mooring belt made with a channel-type ceramic block filled with grout and the foundations are excavated concrete piles. The roof is composed of ceramic tiles on a wooden structure supported by masonry props on the roof slab. The set has a 15cm eaves without a gutter to collect rainwater. The external frames are made of aluminum, with closure made with transparent glass, without opaque closure. The drip trays were also made of concrete and painted in the same color as the masonry.

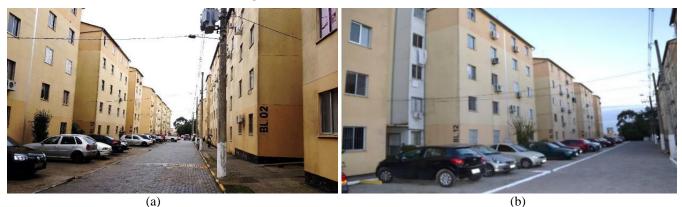
Figure 5: Residencial Estrela Gaúcha.

The Residencial Estrela Gaúcha, with five floors, belongs to the PAR Especial modality and is shown in Figures 5a and 5b. Like the other sets, this residential was also built-in structural masonry of ceramic blocks with floors executed in pre-molded slabs, supported on the mooring belt made with a channel-type ceramic block filled with grout and the foundations are excavated concrete piles. However, unlike the two previous sets, the Residencial Estrela Gaúcha has a roof with fiber cement tiles and gutters to collect rainwater. As in the other sets, the external frames are made of aluminum, with closure made with transparent glass, without opaque closure. The drip trays were also made of concrete and painted in the same color as the masonry.

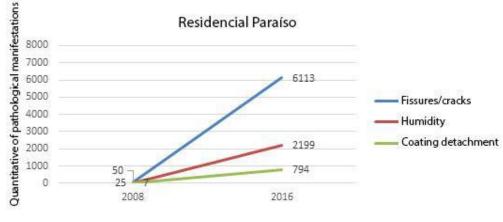
In Residencial Paraíso, considering the same area of observation of facades and only the three main groups of pathological manifestations: fissures/cracks, humidity, and coating detachment, in the INQUALHIS survey only 82 incidences were obtained and in the current survey 9106 incidences. There was an impressive increase of approximately 11105% in the number of incidences over a period of eight years and three months.

Figure 7 was generated to visualize the differences in the incidence of diagnosed pathological manifestations. It is observed that the representation of fissures and cracks presented an increase of 6% in relation to the previous survey. In terms of humidity, there was a decrease of 6% in relation to the previous survey, the coating detachment continues to represent 9% of the anomalies. The predominance of the cracking problem remains evident. This pathological manifestation represents 67% of the problems in the current survey and 61% in the previous one.

Figure 7: Comparison of the incidence of pathological manifestations from the survey with the INQUALHIS survey of Residencial Paraíso.

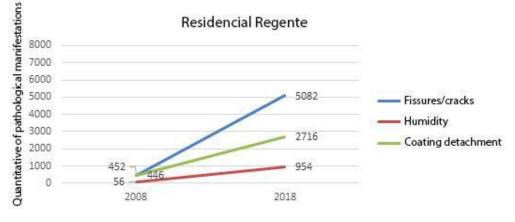
The following graph, shown in Figure 8, shows the incidence of each group of pathological manifestations in the INQUALHIS survey and in the current survey of Residencial Regente. In the INQUALHIS survey, 954 pathological manifestations were diagnosed and in the current survey 9549 incidences, an increase of 1000.94% in the number of incidences in a period of 11 years and 3 months.

Figure 8: Comparison of the incidence of pathological manifestations from the survey with the INQUALHIS survey of Residencial Regente.

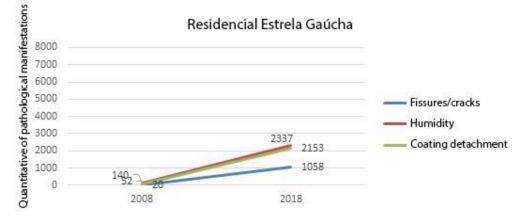
In Residencial Estrela Gaúcha, considering the incidence of pathological manifestations in the two surveys is shown in Figure 10. There was an increase between the two surveys of 3450.94%, increasing from 212 manifestations to 7316 in a period of 11 years and 4 months.

Figure 10: Comparison of the incidence of pathological manifestations from the survey with the INQUALHIS survey of Residencial Estrela Gaúcha.
