## **The role of occupational safety in road works: Implementation of preliminary risk analysis in the execution of asphalt resurfacing**

This research aims to apply the APR technique in each function of the execution process of the resurfacing work of a critical stretch located on Avenida Dona Otília, in the neighborhood of São Pedro in Manaus/AM, in order to diagnose risks and propose improvements in working conditions in each position, meeting the legislation and proposing adjustments for the

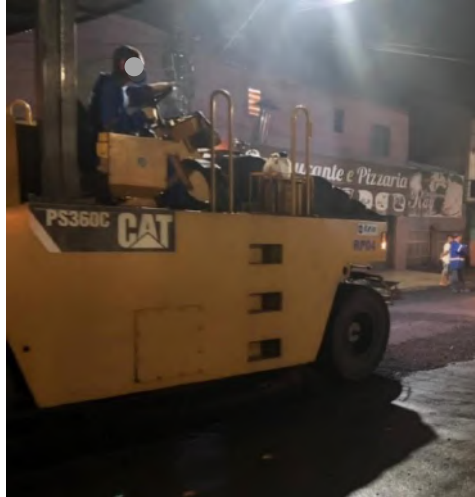
**Figure 2 - Pneumatic Road Roller.**

The pneumatic roller operator is responsible for compacting the materials used in the subgrade, subbase, base and aggregates used in the asphalt layer. The work environment of this function is the equipment cabin, consisting of a seat,

steering and a lever, and, depending on the equipment, a cover (Figure 2 illustrates this environment). The equipment produces 87.7 dB, exposing the worker to physical risk, for example.

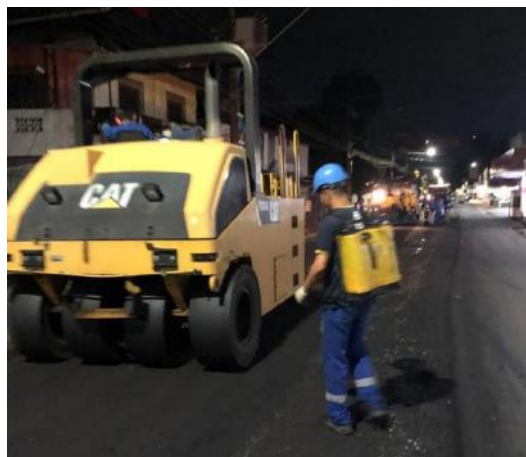
**Figure 3 - Assistant performing his task.**

The function of the auxiliary is to keep the tires clean, since the asphalt mass tends to adhere to the tire rubber, decreasing its compaction efficiency, and can damage it if not removed while it is hot. The auxiliary works in the application of vegetable oil with the backpack pump during the operation of the roller (Figure 3).

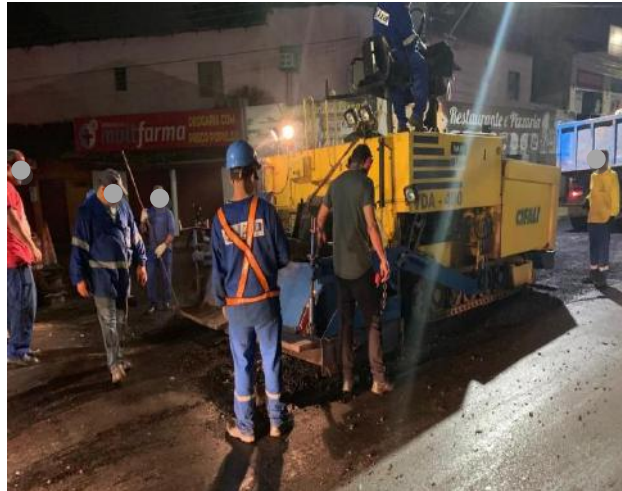
**Figure 4 - Asphalt Paver Operator.**

The paver table has the function of receiving the load of asphalt mix from the supply truck and spreading the material through the vibrating table, producing a smooth and homogeneous surface. The operator has the function of keeping the flames lit to ensure the ideal temperature for the application of the asphalt mix as shown in Figure 4.

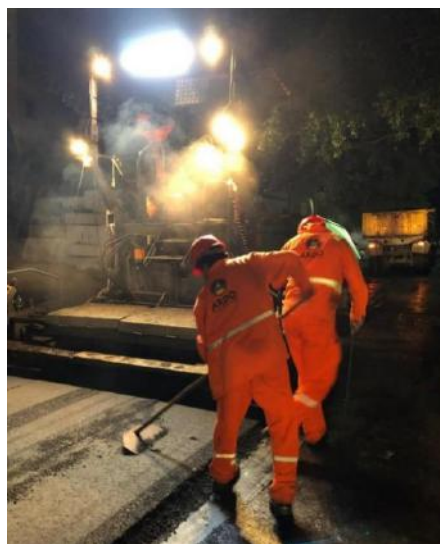
**Figure 5 - The laborers distributing and leveling the asphalt mix.**

The servant's is the position that has the largest number of workers. Their function is to help level the road grade, clean the site before applying bituminous material, unload the aggregate from the truck using shovels, and manually correct the poured aggregate. As this function does not have a machine, the operator does not have a specific work environment, i.e., he remains on the track during the execution of all services, helping the operators and being exposed to sound pressure levels of 87.7 dB. The working day is 44 hours per week and the equipment handled are: rakes, brooms, shovels and buckets (Figure 5).

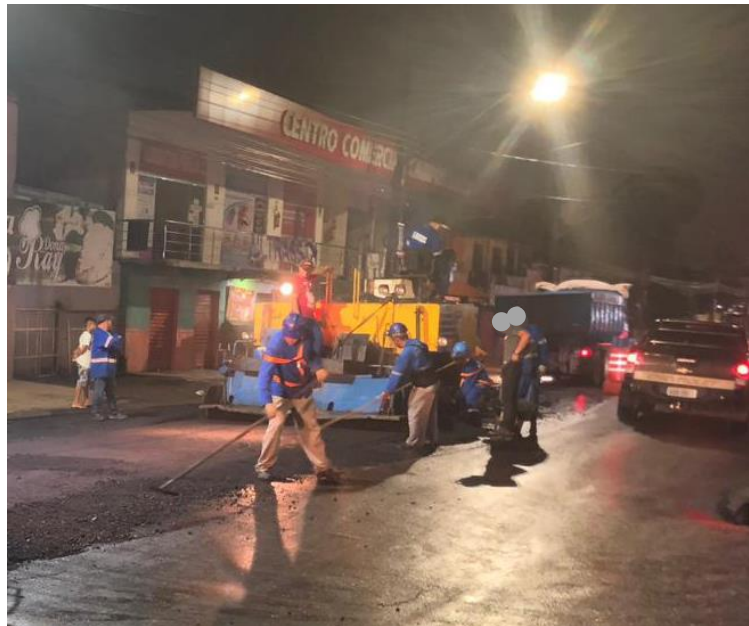
**Figure 6** - Car driving alongside the workers who are working on the stretch.

It was observed that this function is exposed to considerable risks of concern, such as being run over, since the worker remains on the road during various stages of the work, exposed to the traffic of trucks and cars; and the chemical risk due to contact with the bituminous product, as shown in Figure 6.

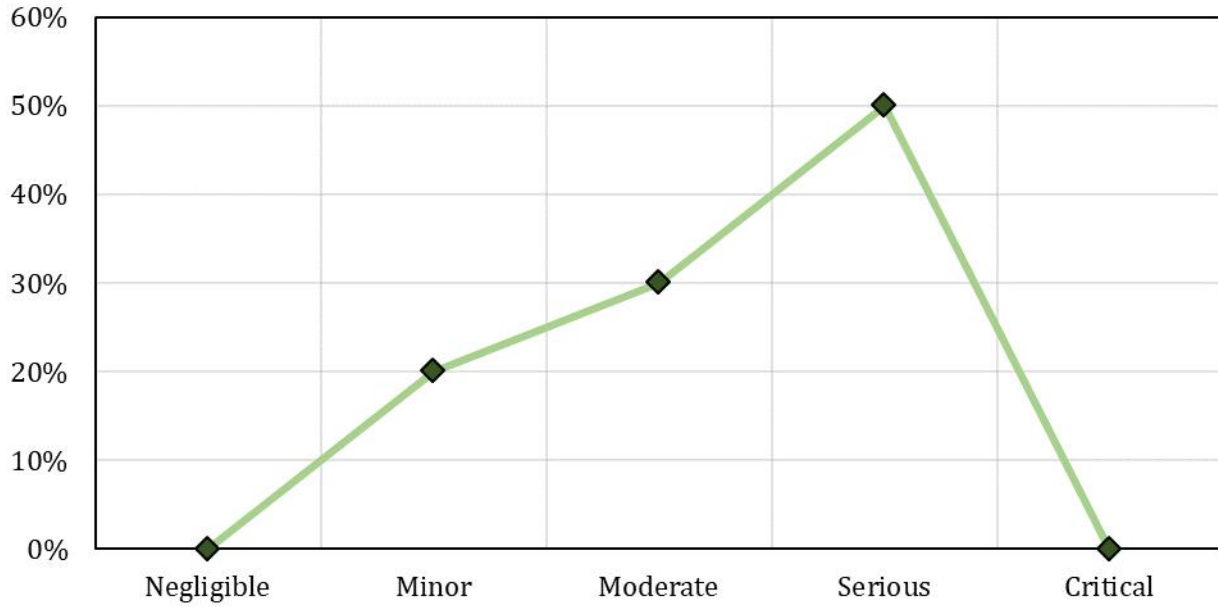
**Figure 7** - Matrix of physical and biological risks classification.

The high level of decibels emitted by the equipment caused the sound pressure level to be classified as high risk, because it may cause, over time, deafness to the operator. The vibration caused by the equipment reaches the operator's body completely, and may cause problems in the spinal column, being a high risk.

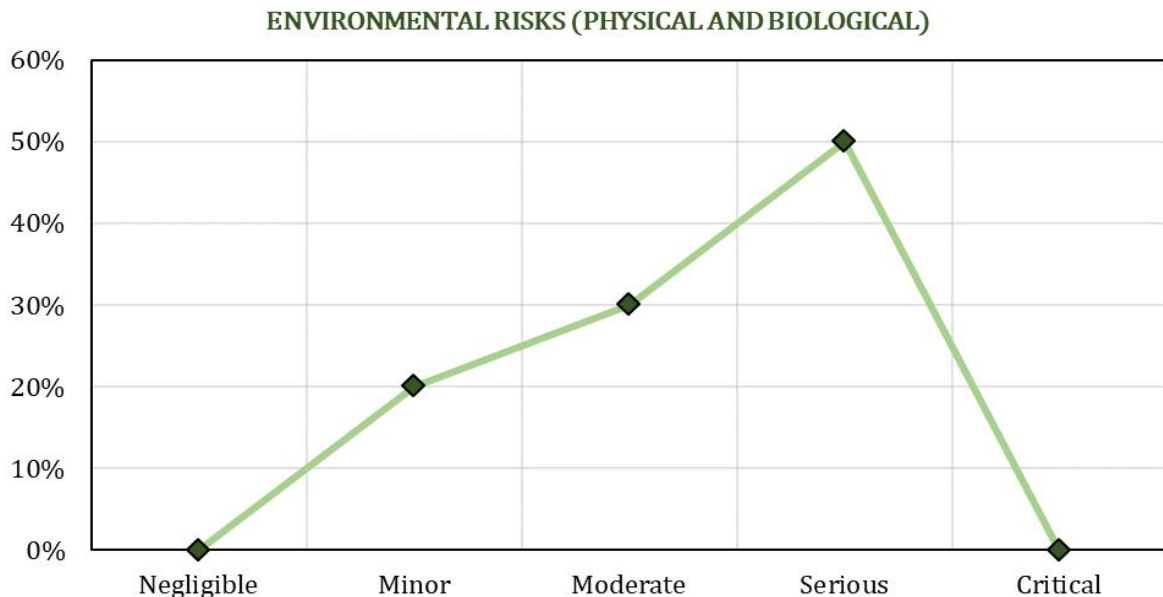
**Figure 10** - Matrix of physical and biological risks classification.

As for environmental risks (physical and biological), according to the risk classification matrix (Table 8), 20% were classified in risk category (2) - Minor; 30%, in risk category (3) - Moderate; and 50% in risk category (4) - Serious (Figure 10). Regarding ergonomic risks (Table 9), they were all classified as category (4) - Serious (Figure 11). Finally, regarding the risks of accidents (Table 10), they were all classified as category (4) - Serious (Figure 12).

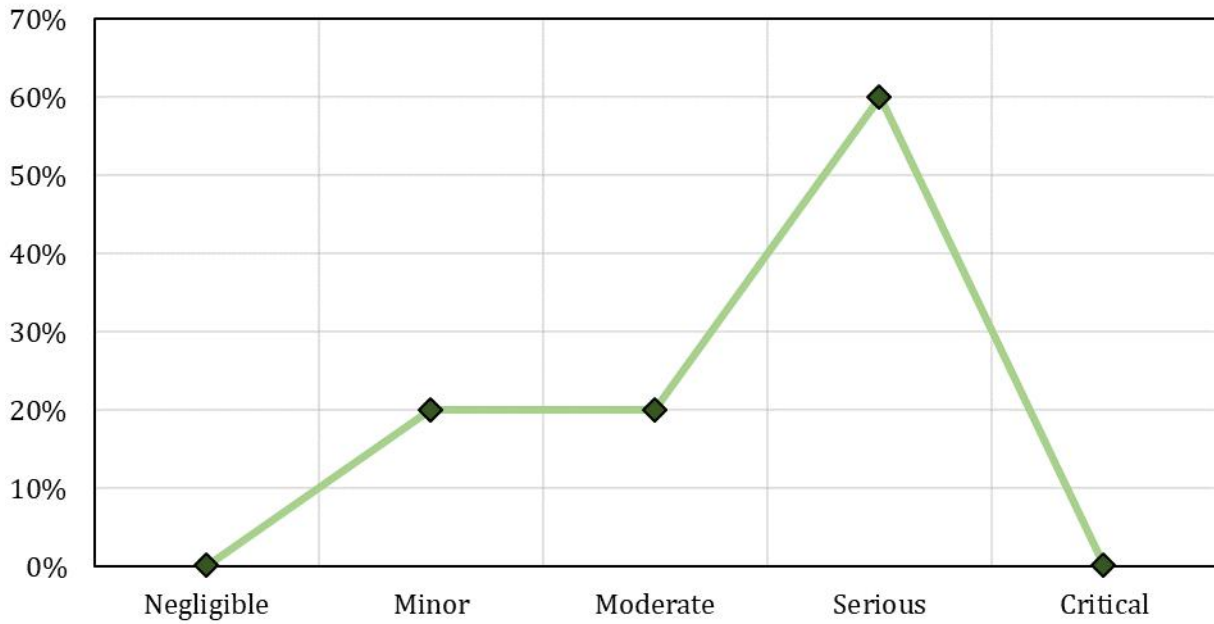
**Figure 13 - Matrix of physical and chemical risks classification.**  
**ENVIRONMENTAL RISKS (PHYSICAL AND CHEMICAL)**

As for environmental risks (physical and chemical), according to the risk classification matrix (Table 11), 20% were classified in risk category (2) - Minor; 20%, in risk category (3) - Moderate; and 60% in risk category (4) - Serious (Figure 13). With regard to accident risks (Table 12), they were all classified as category (4) - Serious (Figure 14).
