Evaluation of the viability of recycling railroad ballast for reusing in railroads

The aim of this study is to evaluate the characteristics of a ballast used on a railway in order to obtain information about its properties. The sample of degraded ballast was collected at yard do Arará - RJ (Figure 1 (a) and (b)), during a change operation of the turnout type, which was in service for approximately 15 years. Both the degraded ballast (Figure 2 (a)) and the new ballast (Figure 2(b)) come from the same quarry. Its particle size ranges from 5 mm to 63.5 mm.

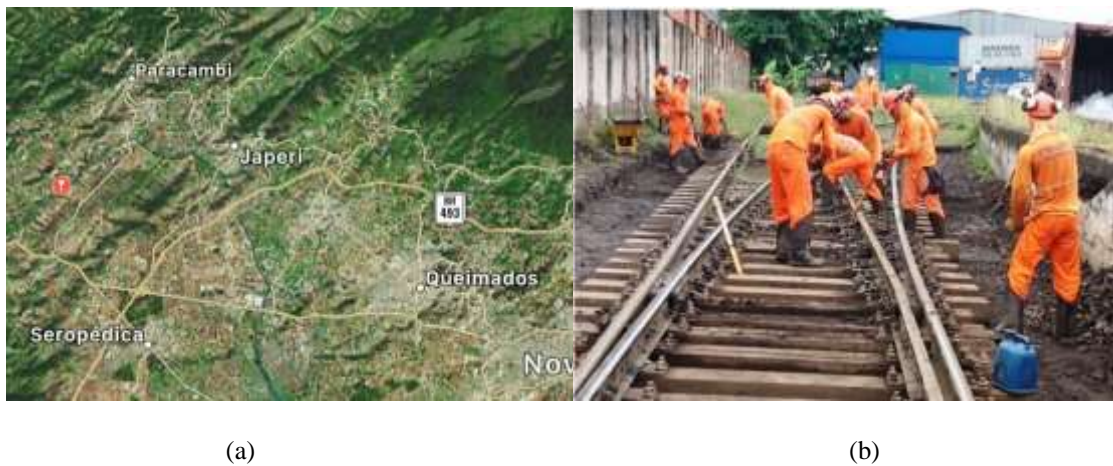
Figure 1: (a) geographic location of the Japeri quarry - RJ and (b) operation to remove ballast from the Arará yard – RJ.

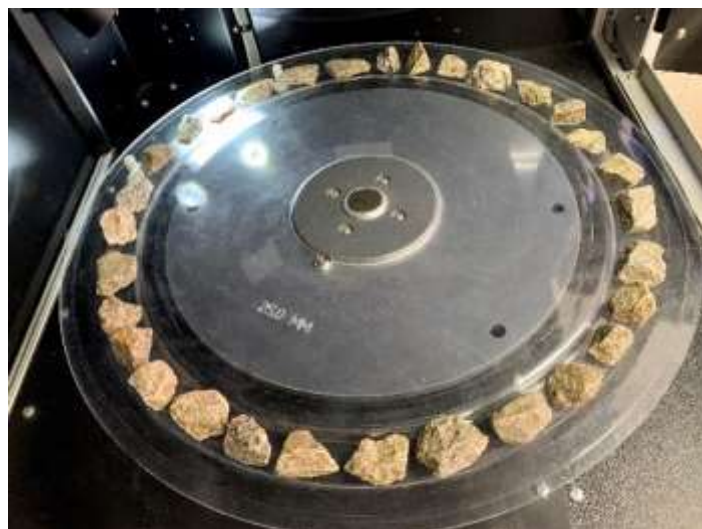
Figure 4: Degraded ballast – AIMS tests.

Ibiapina (2018) carried out a study on Brazilian aggregates and from data of materials from different regions and proposed a change in the classification limits of materials used in the AIMS, which have North American origins. The limits proposed are shown in Table 1. Figure 3 shows the AIMS equipment and accessories used for image capture and Figure 4 shows the degraded ballast in AIMS tray.

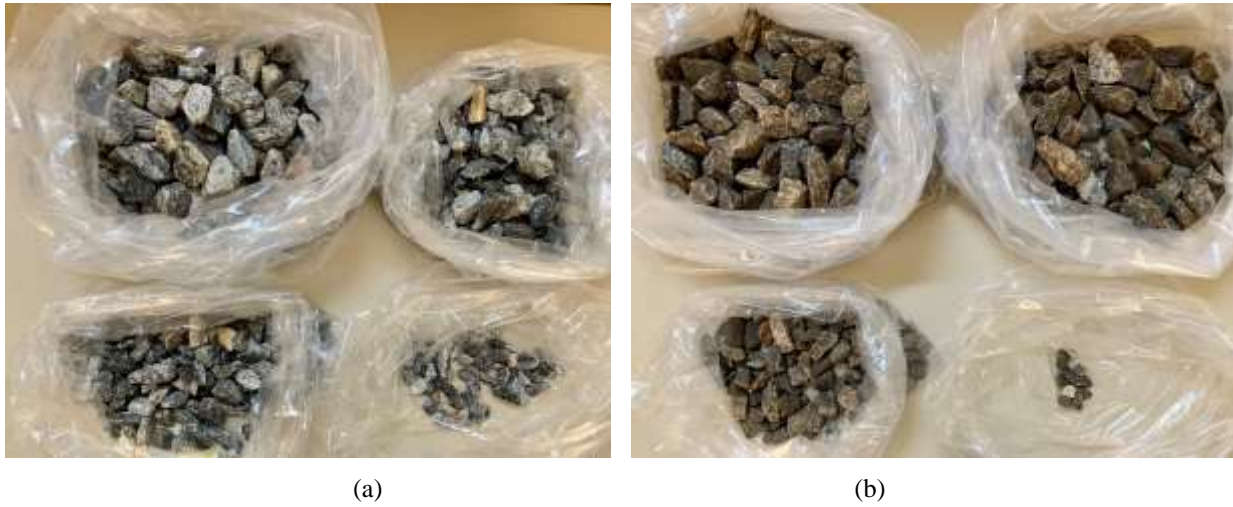
Figure 5: New (a) and degraded (b) ballast separated by particle size for testing.

The shape of the aggregates was obtained using AIMS equipment. The test was performed both on new ballast and on degraded ballast. The sample of each material consisted of 50 particles of the fractions retained in each of the sieves: 9.5 mm, 12.5 mm, 19 mm and 25.4 mm (Figure 5).
