## **Successful outcome of surgical reintervention for implant placement in borderline aesthetic area related to agenesia: a case report**

### **Abstract**

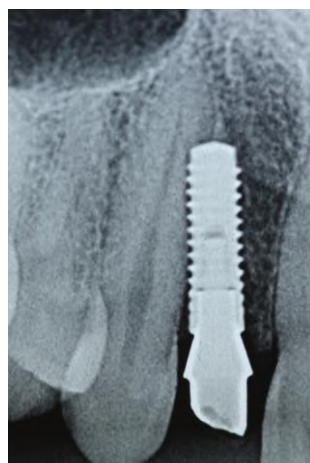
The patient had postoperative periapical radiographs, and it was possible to visualize the presence of an implant, which was located in the middle third of the right superior canine mesial root surface and was facing the coronary third. The distal proximal surface of the right upper central incisor was preserved (Figure 1). The patient recalled that she felt severe pain in the postoperative period, and the implant was removed at this point in the patient's treatment course. She also reported good overall health.

**Figure 1:** X-ray image evidencing failure in the initial implant position.

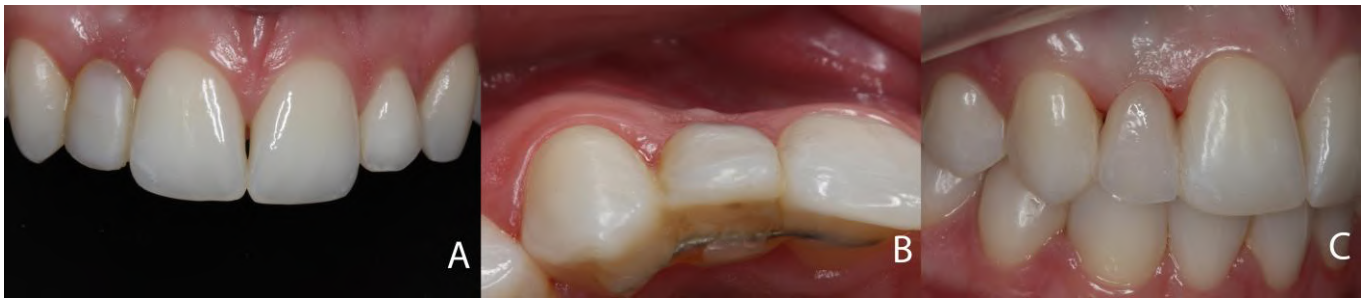
In the clinical examination, a resin adhesive prosthesis was glued to the adjacent teeth with the aid of an orthodontic wire and composite resin, and the tissue margins appeared swollen. Because of the complaints and observed conditions, the prosthesis was removed, and a new adhesive prosthesis was initially made to promote hygiene and emotional comfort for the patient (Figures 2a, 2b and 2c).

**Figure 2:** 2a- initial front view of the smile; 2b- incisal view of the initial resin adhesive prosthesis; 2c- new resin adhesive prosthesis in place.

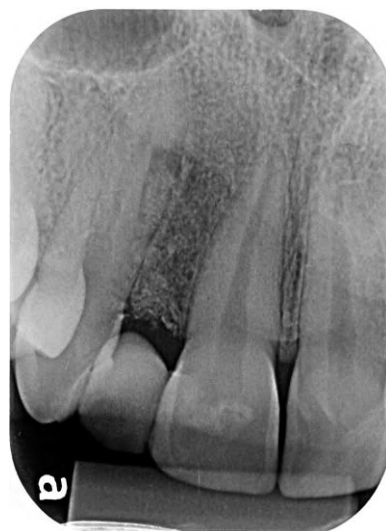
Subsequently, a periapical radiographic examination of the area was requested, showing an interruption of the peri-cement line and a radiolucent area in the middle third of superior right canine, suggesting external root resorption. This finding was asymptomatic due to a lack of pulp involvement. In this case, external root resorption was caused by the loss of dental structure, which was generated by contact of the implant with the root structure. Additionally, the presence of trabecular bone in the whole implant socket was noted (Figure 3).

**Figure 3:** X-ray image revealing interruption of the peri-cement line, radiolucent area in the middle third of the tooth 13, and presence of trabecular bone in the implant socket.

Given the favorable aesthetic conditions presented by the new fixed prosthesis and the restoration of the health of the surrounding soft tissue, a case control was chosen since the prognosis of tooth 13 was unclear. In addition, the patient clearly expressed a preference to retry implantation if possible.

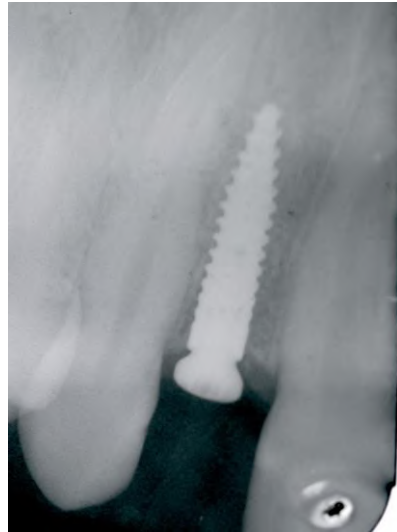
To stabilize the subepithelial graft, a periosteum suture in the middle third of the keratinized mucosa, as well as two simple sutures in the region of future papillae, was performed. At the end, a periapical radiograph was performed by the parallelism technique, and the radiograph confirmed perfect positioning of the implant in relation to the adjacent natural pillars (Figure 5).

**Figure 5:** X-ray image evidencing correct implant positioning.

A sharp drill with a 1.6 mm diameter (Straumann Dental Implant System) was centered in the space, in both the mesiodistal and buccal-palatine directions, and drilling began under irrigation (saline) and a velocity of 800 revolutions per minute (rpm). The first millimeters of the osteotomy were performed, and at each millimeter of drilling, radiographic scans were taken until the root strangulation region was exceeded.

From the depth of 4 mm, parallelism with the adjacent teeth was verified, and once risk of injury to those teeth was eliminated, drilling continued until the necessary depth of 12 mm was reached.

The 2.2 mm thick helical pilot drill was also used under irrigation and at a constant speed of 800 rpm. With the alignment pin, parallelism and the depth were assessed and approved.

The final preparation of the socket was performed by the 2.9 mm diameter profile drill at 300 rpm, and threading was performed with the thread promoter at 15 rpm to a depth of 8 mm, completing this step.

The implant (BLT 2.9 mm SC, Loxim SLActive® 12 mm, TiZr - Straumann Dental Implant System) was installed with ratchet assistance, and high primary locking was obtained. A ½ mm locking screw was installed.

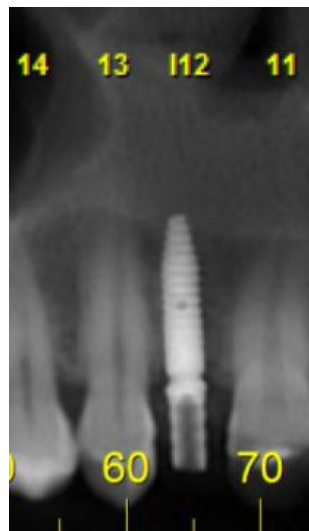
Then, a new tomographic examination was requested to assess the postoperative conditions, including the conditions related to resorption in tooth 13. Regarding inflammatory resorption, once the causal factor was removed, according to the tomographic images, there were signs of repair of the area, and according to the results of a pulp sensitivity test, the pulp integrity was maintained (Figure 7).

**Figure 7:** Computed tomography image revealing repair of the tooth 13 radicular resorption.

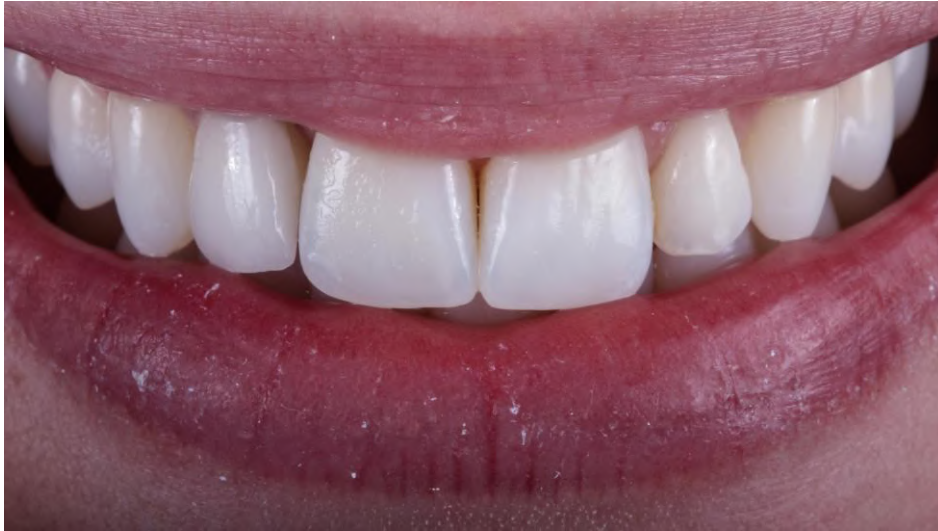
Thus, it was possible to complete the processes required to restore the soft tissue health, dental aesthetics, and self-esteem of the patient (Figure 9). After 12 months postoperatively, positive conditions related to the stability and health of the gingival margins, as well as a favorable implant response to the imposed loads, were noted (figure 10). Annual visits to control the tissue margin stability and implant conditions and to understand the behavior and longevity of the small-diameter implant considered here were suggested for the patient.

**Figure 9:** Final view of the smile.
